Environmental impacts of the Rio Esti Hydroelectric Project, Panama

Erik Wall

This paper has been done as a project course of 15 ECTS points in Aquatic- and Environmental Engineering at Uppsala University, Sweden.

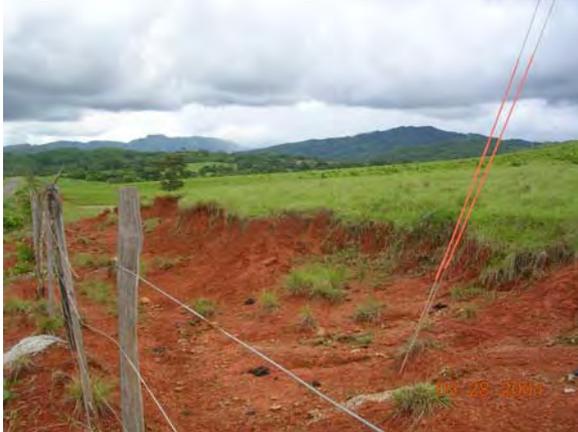
The land in the area is mostly used for cattle. To clear land for extensive cattle herding, wide spread deforestation has occurred. As a result of this deforestation, in combination with poor land protection, high precipitation and high erosive tendency of the soils, erosion and soil degradation is a severe problem in the area (Fig 4.2).¹⁰

Fig. 4.2 Erosion is a problem in the area, and was so prior to the Rio Esti Project, due to poor land management.

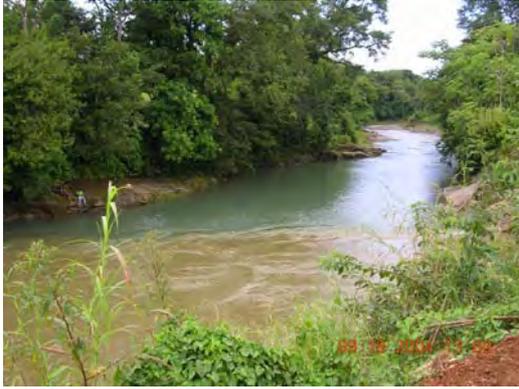
The Esti River has a greenish colour upstream from the turbine discharge. The discharge water has, however, a strong brown colour and when mixed with the Esti River, the colour of the river water changes substantially. Further downstream from the discharge, the river regains most of its natural colour.

Fig 5.1 The greenish water of the Esti river mixes with the brownish water from the turbine discharge. Picture taken just downstream of Canjilones power house (z17 E- 357385 N- 944866).

Hence, it is not unrealistic that the measured decrease in conductivity indicates a problem with oil leaks from the powerhouse in Canjilones. Oil can severely affect aquatic life. Therefore future water monitoring programs should include analyses of oil and hydrocarbon

content in the Esti River. If these samples indicate problems with leaking oil, actions need to be taken to stop this leakage.

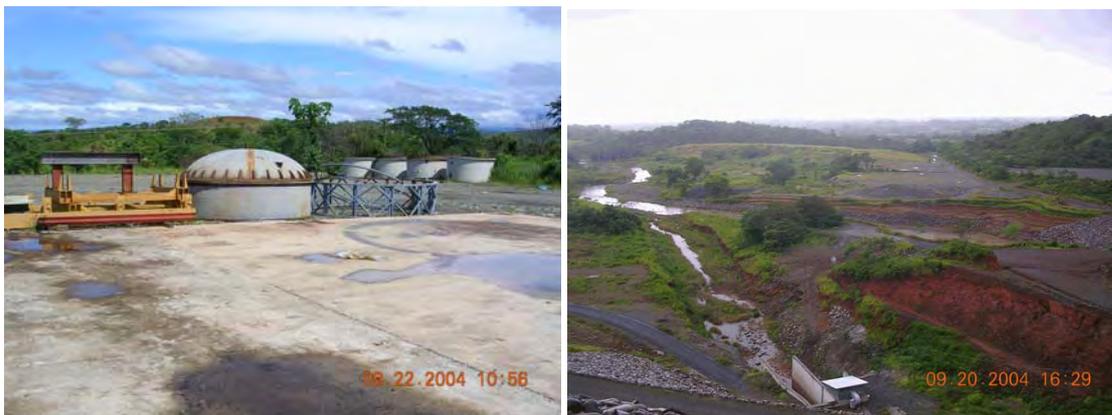
At the time of the study there still remained debris, buildings and hard structures at a number of these sites (Fig 6.3). At some sites topsoil had been added and grass planted, whereas other sites had no debris or structures but have been left to natural re-colonization (Fig 6.4).

Fig 6.3 To the left (z17 E- 357250 N- 945165), hard structures and debris remain at some sites in the area. To the right (z17 E- 351752 N- 949623), the highly affected area just south of the Barrigon dam, big parts without any land preparation or vegetative cover.

As has been noted in earlier studies, there is still debris lying around at some sites and old abandoned access roads are left unprepared for re-vegetation⁵⁰. No activity to change this situation was observed even though the EIA states that it should.

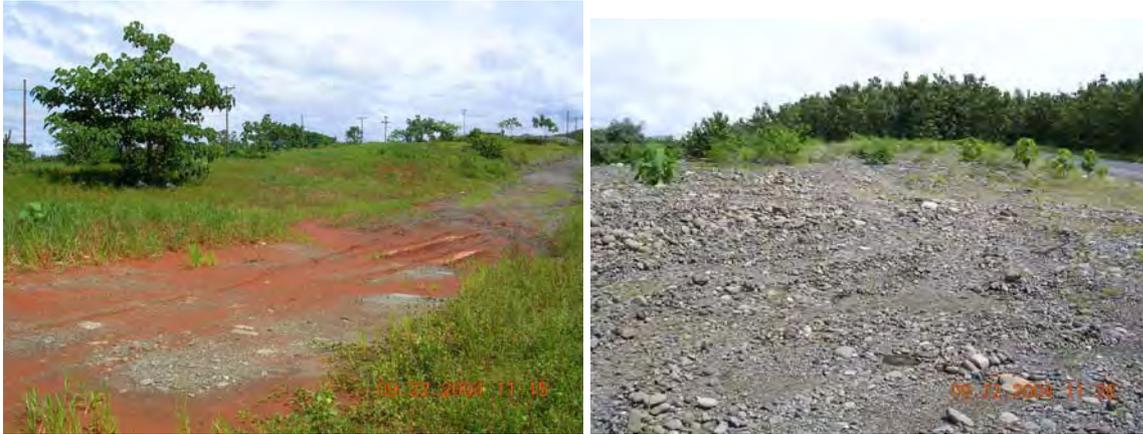
Fig 6.4 To the left, the site where *vegetative_cover* was mapped (z17 E-357197 N-944787), top soil has been added and grass planted. To the right, the site where *vegetative_cover_2* was mapped (Fig 6.6) (z17 E-357292 N-945397), excavated material from the conveyance tunnel has been placed at this site. The site is left to natural re-vegetation.

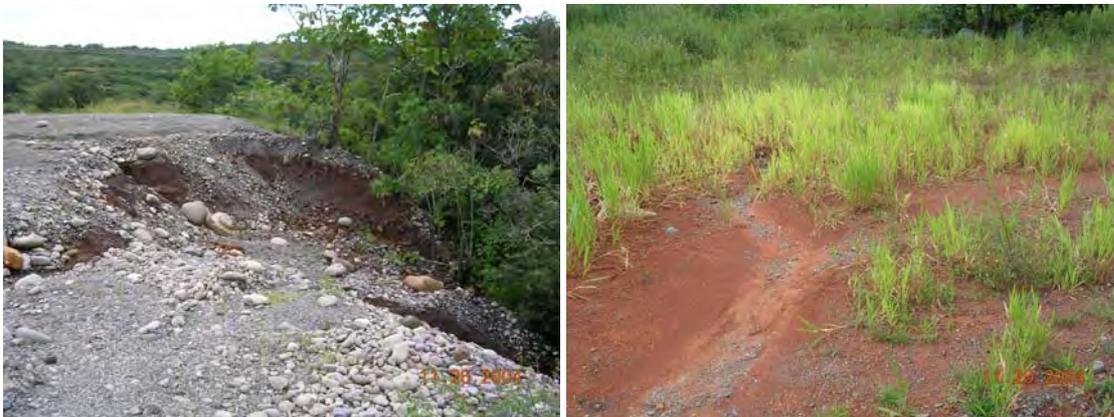
Where topsoil have been added and grass planted the vegetative cover is higher than at similar nearby areas left to natural re-colonization (Fig 6.6). The cover is however uneven also at actively re-vegetated sites. As a result, the added topsoil is eroding to some extent (Fig 6.5). The problems with erosion seems, maybe a bit contradictory, to be bigger at areas where topsoil has been added and active re-plantation performed than at areas left to natural re-vegetation. The ground at abandoned sites with no added topsoil is often very compact and consists mainly of gravel or stones, material resistant to erosion because of their size and weight. Erosion that is observed at these sites is almost solely occurring as gullies forming in slopes. (Fig 6.5)

Fig 6.5 To the left, gullies are forming at an abandoned site (south of Barrigon dam) left to natural re-colonization without any land preparation actions. To the right, erosion at a site where topsoil has been added and grass planted (z17 E-357197 N-944787).

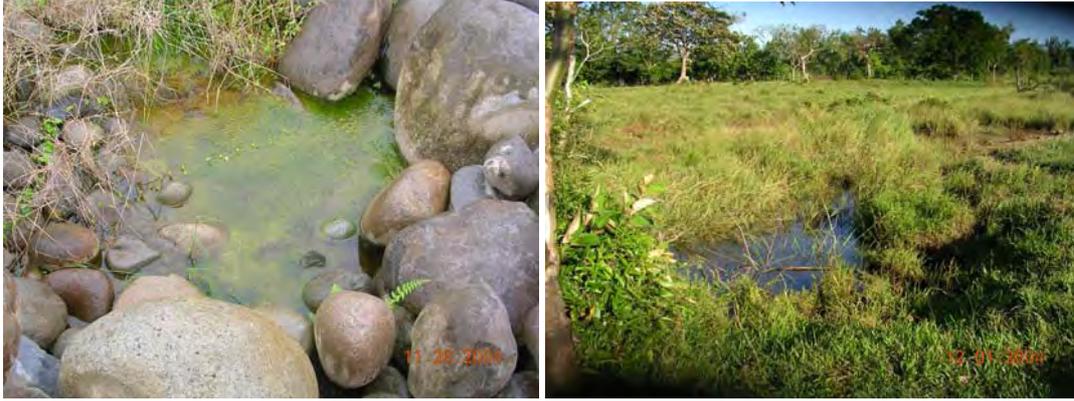
Water is sipping through the old quarries and forming small ponds (Fig 6.7). Fry and algae can be seen in these ponds and there are some species of wading birds seen around the sites. However ponds of stagnant water can in tropical areas be the ground for malaria mosquitoes, other disease carriers and bacteria. Not enough time has elapsed since the abandonment of the quarries to see if the health situation has been affected for cattle or humans in the proximity to them.

Fig 6.7 To the left, small ponds with stagnant water are forming in the old quarries in the Chiriqui River (z17 E- 354593 N- 948341). To the right, old water holes in cattle pasture showing that stagnant water is not a new occurrence in the area.

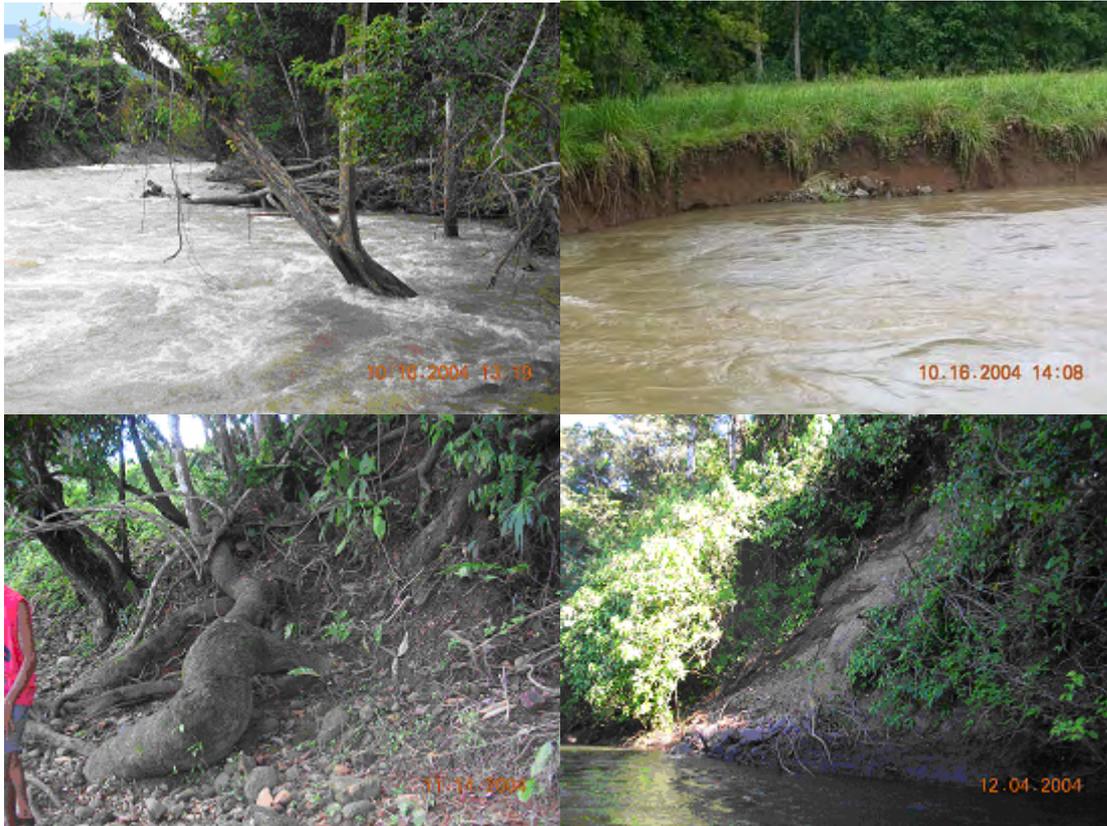
The effect of the altered flow in the Esti River is substantial river side erosion (Fig 6.8). How the people in the area are affected by this altered flow is discussed in section 7.

Fig 6.8 The sides of the Esti river is eroding due to the increased flow.

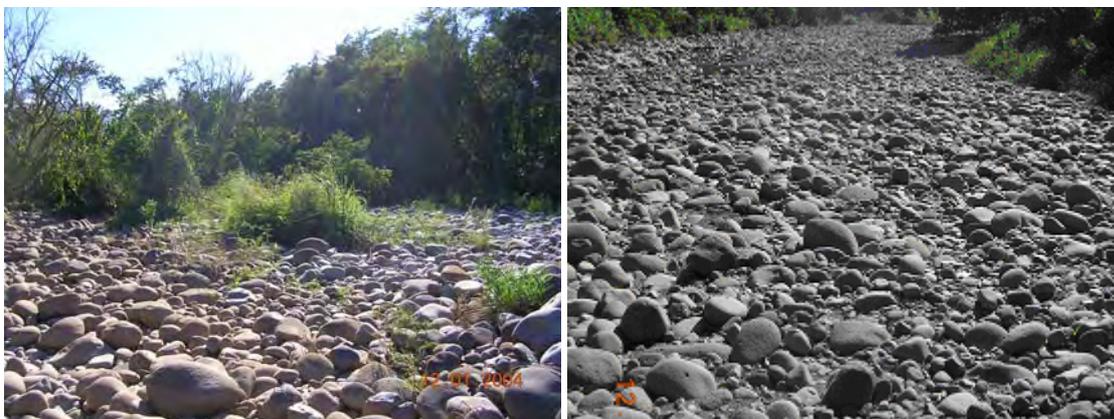
This old river bottom shows in most places no sign of any re-vegetation. Since deposited soil and plants which are starting to colonize the river bottom are frequently swept away by the high flows that are flooding the river bed, no re-colonization is likely to ever occur. Re-vegetation can only be seen at places with higher altitude or just upstream from the small islands that exist. These are areas that are not flooded with the same frequency and where the water velocity can be assumed to be lower than at other sites in the river during peak flows (Fig 6.9).

Fig 6.9 The old river bottom of the Chiriqui River. At some higher grounds some plants have managed to grow (left picture, z17 E- 355566 N- 943311). The majority of the old river bottom however, is completely without vegetation (right picture, z17 E- 355468 N- 943082).

If plants are to re-colonize the old river bottom, a significant deepening of the main channel has to be made, so that the water does not flood the entire river bottom and sweep away newly colonized plants when the flow is increasing.

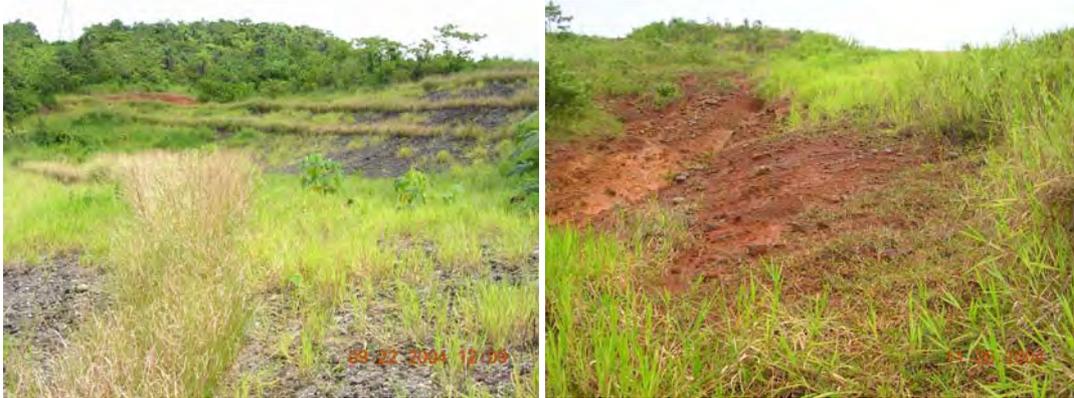
A lot of effort has been put into replanting slopes where erosion is most likely to occur. The method most widely used is that of vegetative terraces with *Brachiaria humidicola* grass (Fig 6.10). The vegetative terraces are normally combined with the earth being moved into terrace structures. At most places these methods work fine to protect erosion. However, at some sites, namely around the pressure chimney, below Barrigon Dam and on the southern slope of the canal there are signs of gullies starting to form even though vegetative terraces have been planted (Fig 6.10). These gullies are likely to widen with more rain if action is not taken to restore the erosion protection.

Fig 6.10 Vegetative terraces with *Brachiaria humidicola* to prevent erosion. Even though the vegetative terraces at most places are successful in preventing erosion there are places where eroding gullies are starting to form. Reconstruction of some terraces is needed. (z17 E- 357355 N- 946260)

The vegetative terraces constructed to avoid erosion are mostly working. Some do need to be repaired since erosion has started and is likely to increase. An inventory of where repairs of the terraces are needed should be performed in the close future. This is also the intention of AES Panama. However, not at all erosion susceptible slopes have been planted. Thus there is a need for an extension of erosion protection measures.

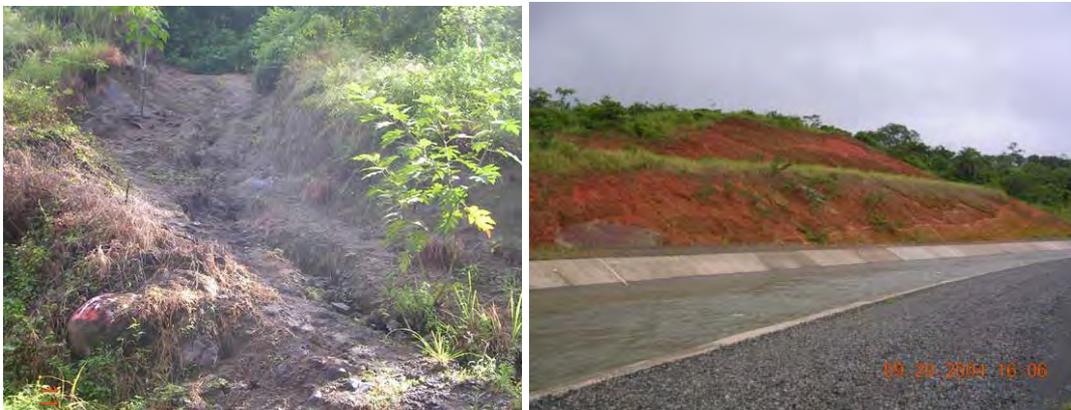
Moreover, there are bare slopes on the north side of the diversion canal where erosion can be observed (Fig 6.11). Below the Barrigon dam and along some of the roads there are also slopes without vegetative cover where erosion can be seen or are likely to occur. These sites need to be planted to avoid erosion and possible damages on project structures.

Fig 6.11 Left, a number of no longer used roads are left un-restored and erosion is occurring. To the right, terraces adjacent to the canal without sufficient vegetative cover are showing traces of erosion (z17 E-354002 N-950221).

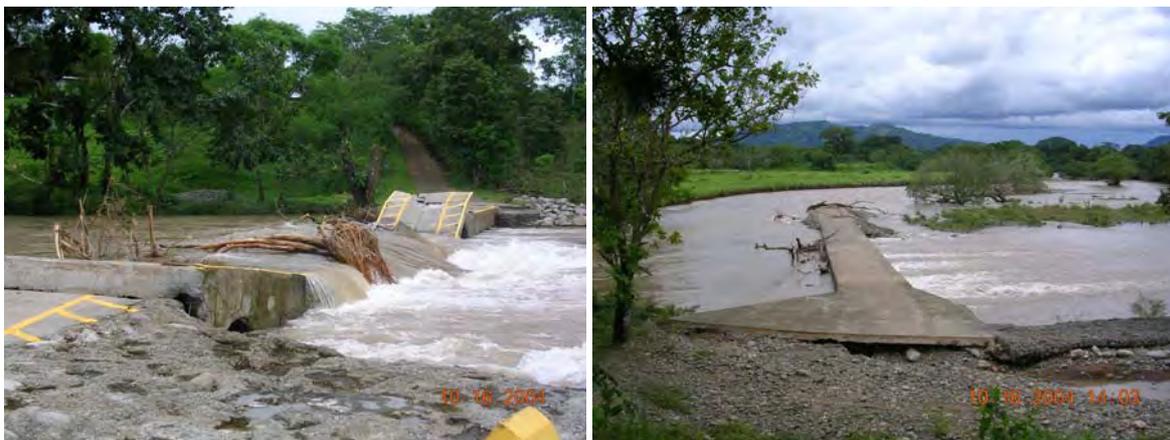
The crossings were inadequately constructed. At the time of this study, around a year after the project completion, two of the crossings were completely destroyed due to high flows, trees floating in the river and river side erosion (Fig 7.2). One of the crossings was severely inundated and caused great danger for people needing to cross (Fig 7.3). The fourth crossing was still intact at the time of the study.

Fig 7.2 Two of the ineptly constructed Irish crossings over the Esti River, destroyed by the high flows (left z17 E-359863 N-939991, right z17 E-359841 N-939053)

Since the Irish crossings had been approved by the MOP and were transferred to their management when they collapsed, AES was not legally obliged to do any reconstruction. However, since the crossings were obviously badly constructed, AES accepted a moral obligation for the situation and commenced the construction of three new bridges in November 2004, two hanging bridges for humans and cattle and one bridge allowing vehicles of up to seven tonnes to cross the river.

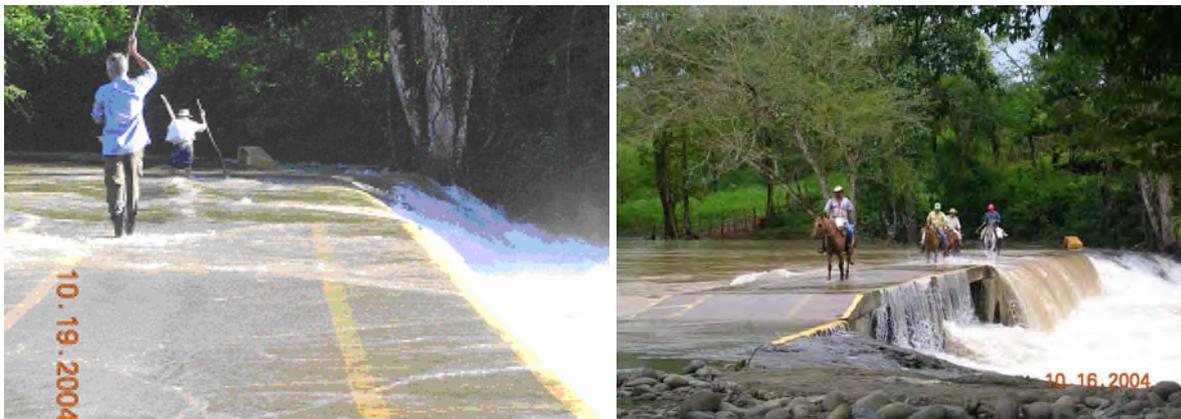
Fig 7.3 The inundated crossing used by people in Higuera to get to and from their fields or works (z17 E. 360772 N-937458).

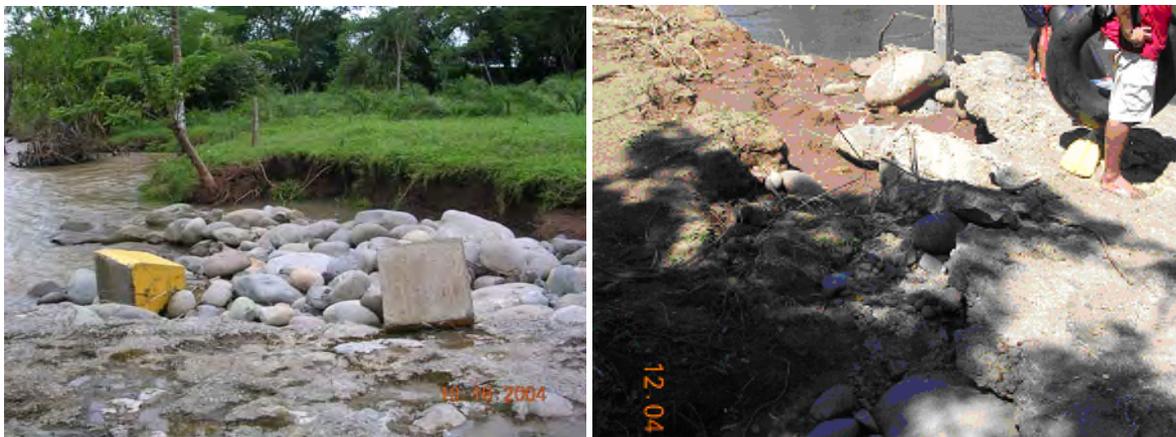
Fig 7.4 The river side adjacent to the Irish crossings shows proof of severe erosion (left z17 E-359863 N-939991, right z17 E. 360772 N-937458).

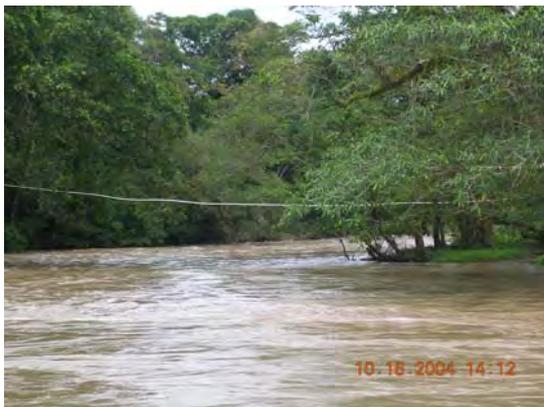
The spring supplying the aqueduct with water is located some distance away from the community. The aqueduct passes over both the Gualaca and the Esti Rivers before reaching Higuieron. Occasionally, during the rainy season, the aqueduct has been destroyed by high flows in the Gualaca River. Prior to the project this never occurred due to peak flows in the Esti River. However the Esti River has today, due to the discharge water from the Canjilones power station, a flow some 12 times higher then it had prior to the project. And since the finalisation of the project, the aqueduct has been destroyed several (2-3) times where it crosses over the Esti River.^{48, 49}

Fig 8.1 The Higuieron aqueduct passing over the Esti river. Since the project completion it has been swept a way by high flows 2-3 times. There is a risk that the footing on the eastern (right) river side will erode away in time. This would significantly worsen the situation in Higuieron. (Picture taken from z17 E-359841 N-939053, direction N)

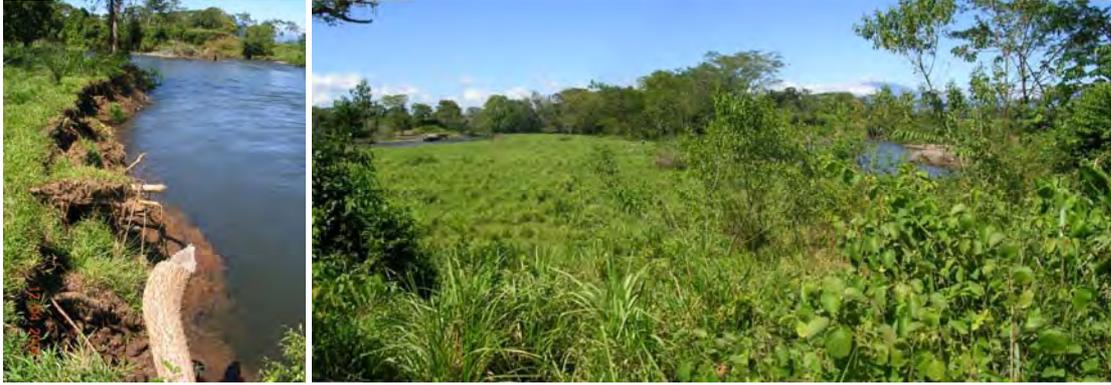
Furthermore, with the increased flow of the Estí River the river pattern is now likely to change into having a less meandering characteristic. When travelling downstream on the river from the discharge at the Canjilones powerhouse, river side erosion can be seen along almost the entire length of the river down to its confluence with the Gualaca River, also where the aqueduct crosses the Esti River, and even if the aqueduct is elevated, it is likely that the tree that serves as footing on one side of the river will erode away in some years. Moreover, the aqueduct crosses over the Esti River where the river bends around a low promontory (Fig 8.2). With the increased flow there are signs that the river will erode and transform this promontory into an islet. The difficulties and costs for having the aqueduct cross the river will then be multiplied.

Fig 8.2 Left, the Esti river is eating into the low promontory (right) where the aqueduct for Higueroón crosses the Esti River.
