Nutrient removal of domestic waste water in constructed wetlands in Cochabamba, Bolivia

Project work (7.5 + 15 hp)
Aquatic and environmental engineering
Department of Air, Water and Landscape Science
Uppsala University
Supervisors:
Christian Bomblat, Roger Herbert,
Lars Hylander and Barbro Ulén

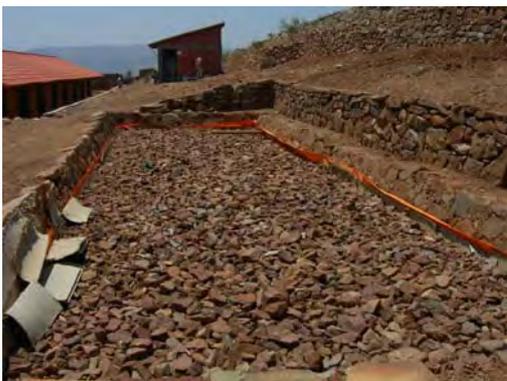
Figure 4 Constructed wetland at San Nicolas elementary school.

The school has an agreement with the government to have their two water tanks, in total 10,000 litres, filled up once every week. So far this has not worked so well, sometimes they do not come at all or most of the water is bought by people further down in the valley. The water in the tanks is led down to the toilets and showers. From here the used water then goes into two septic tanks holding 3,000 litres each. From the septic tanks the water is lead through plastic tubes to the wetland where it is equally spread over the short side of the wetland. The constructed wetland has a 20-25 centimetre bottom layer of compacted clay to protect the water from contaminating the groundwater. The clay layer is covered with a plastic foil to further prevent leakages. Over the plastic linen a layer of stones and gravel is put. This layer is 1.20 metres thick and the water is supposed to reach maximum one metre above the bottom to prevent it from exceed the gravel layer. From the constructed wetland the treated water is then collected into a tank holding 1,200 litres. The treated water is then distributed through a plastic tube system to 150 planted trees. The whole system is driven by gravity force only.

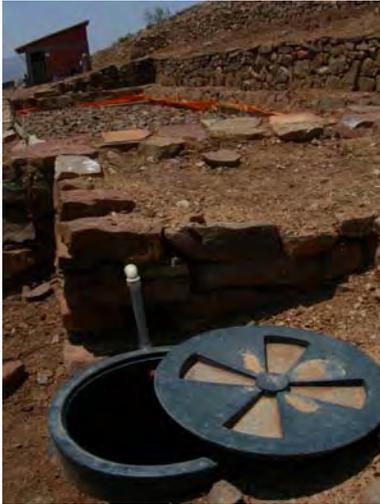
Figure 6 Septic tank at San Nicolas elementary school.

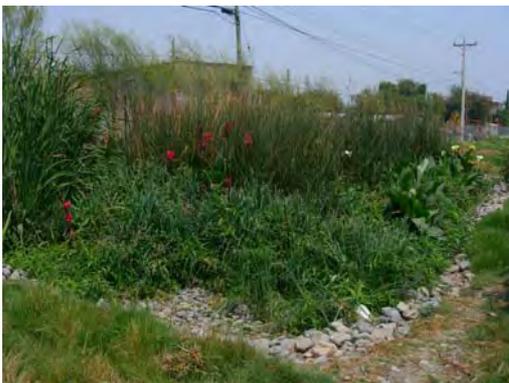
Figure 8 Constructed wetland at SOS.

The waste water that leaves the kitchen, toilets and showers is first collected in a septic tank. This water is then led to a constructed wetland consisting of gravel material which the water is led through. Finally the water is collected in another tank containing 150 litres. On the gravel of the wetland a mixture of paper reed, *Cyperus papyrus* L., and bulrush, *Typha latifolia* L., has been planted and grows in great amount. Last time it was cut down was about two years ago. After the wetland the water ends up in another tank from which the water is used as irrigation water on one of the fields in the school area.

The water in the constructed wetland at SOS – Aldea Infantil was above the surface of the gravel filter at some of the visits. This may influence the treatment in a negative way. However, with a regulation of the outflow or simply by filling up with more gravel this can be adjusted. Surfacing was not observed at the other two sites.

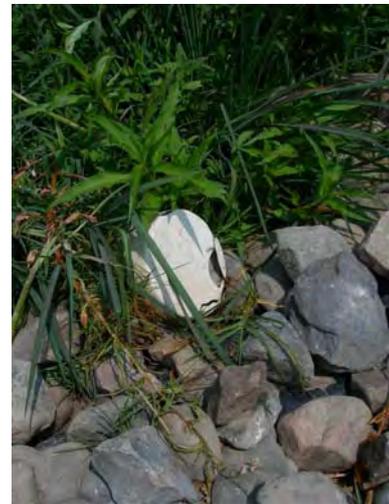
Figure 9 Observation pipe.

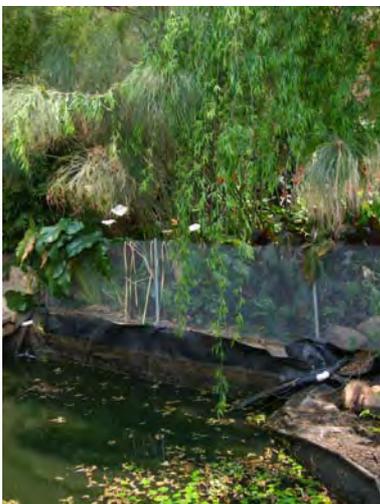
Figure 11 Constructed wetland at a private home.

Waste water from the kitchen, toilets and showers are first collected into a system of two septic tanks. When the water leaves the second tank it is led into the constructed wetland. This is built from gravel placed on plastic linen where plants have been planted on top. The vegetation is in abundance with tall plants, mainly paper reed, *Cyperus papyrus* L., and bulrush, *Typha latifolia* L. These plants were last cut down one year ago. The wetland is also divided into three departments so it flows in a zigzag way down. After the wetland the water flows out into a pond where fishes, frogs and turtles live. The water in the pond is then partly used for irrigation of the garden, and the rest of it is disposed into the surroundings.

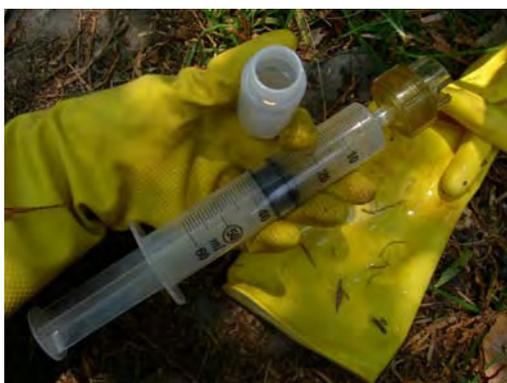
Figure 15 Injector for filtration of DOC-samples.

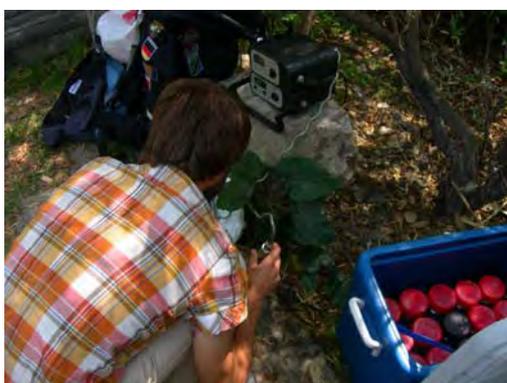
Some of the parameters of interest were measured directly in the field. Oxygen was measured with a WTW Oxi 191 and conductivity with a WTW LF 191. The measurements were performed with the instruments directly in a container with a representative sample of the water. The oxygen level was measured immediately to make sure that the oxygen level had not changed.

Figure 16 Measurement with conductivity meter.

The equipment borrowed from the Department of Limnology was quite old. It seemed trustable but had some defects. For example every setting was dislocated one step when choosing what to measure. Because of this the first oxygen measurement was misread. Another source of error due to the equipment was that the conductivity meter could not be set to the low pressure that corresponds to the high altitude in Cochabamba. This might have affected the absolute values of the conductivity numbers. However, the relative differences are probably not affected.

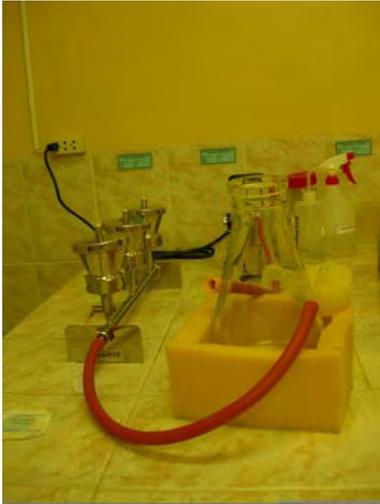
When analysing the samples for fecal coliforms, the 9222-D-method was used with multi-tube membrane filters. Different dilutions of the samples were sucked through filters where the bacteria got caught. The filters were placed in an oven with a constant temperature of 44.5 °C and after 24 hours the number of bacteria on each filter were calculated manually.

Figure 18 Laboratory equipment for measurement of pathogens.

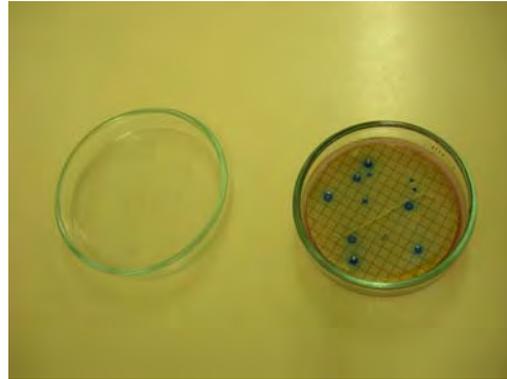
Figure 19 Filter with fecal coliforms.
