Physical and Chemical Assessment of Streams in the sub-Andean Amazon, Peru

Minor Field Study 139
ISSN 1653-5634

Final thesis (30 ECTS)
Environmental and Aquatic Engineering
Department of Earth Sciences, Air, Water and Landscape Science, Uppsala University
Supervisors: Allan Rodhe, Lina Lindell and Willy Vasques

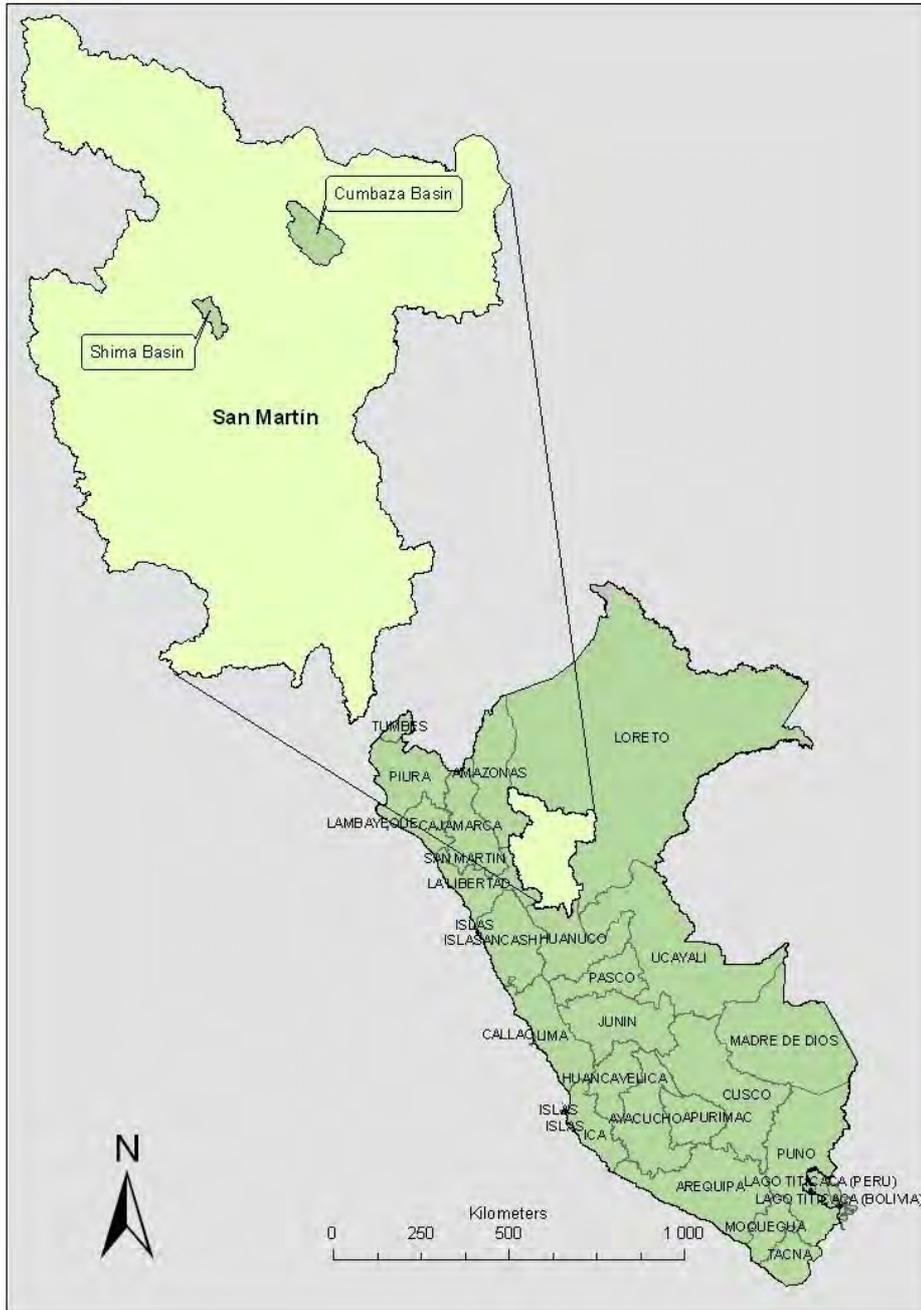
Figure 2 Map showing the departments of Peru and the location of Cumbaza and Shima basins in San Martin.

Within the region of San Martin two watersheds, Cumbaza and Shima (Figure 2), were selected as study areas for this project. Both basins are located in the highland rainforest and are part of the Peruvian Yungas. The Yungas are characterised by high levels of endemic flora and fauna species and its extreme biodiversity makes it internationally important (Nagel, 2005). Today an uncontrolled migration flow together with an unsustainable slash and burn agriculture put pressure on the environment in this whole region (Nagel, 2005).

The Cumbaza basin is located in the north eastern part of the department of San Martín, partly in the province of Lamas and partly in the province of San Martín (Figure 2). Due to many economic activities connected to the river, the Cumbaza River is considered one of the most important rivers in this area. This is partly caused by the location of the biggest city of the department of San Martín, Tarapoto, which is situated in the lower parts of the Cumbaza basin, just by the river (Ministerio de agricultura et al., 2006).

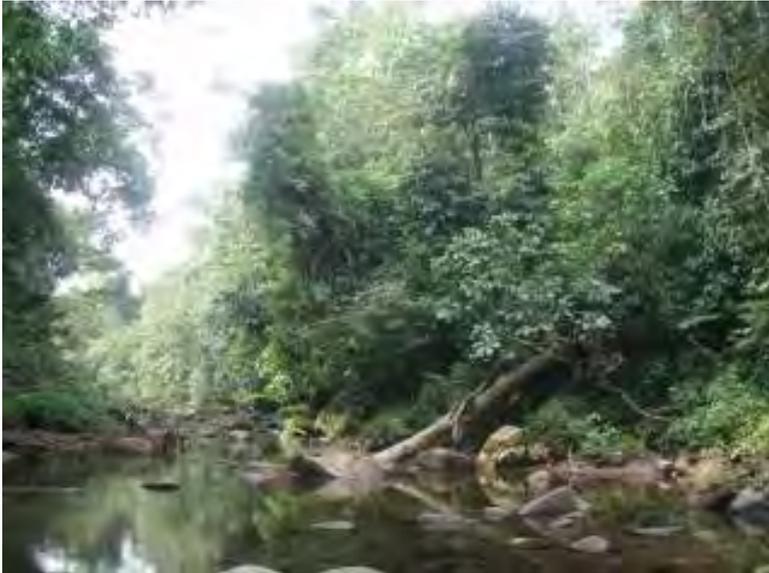
Figure 3 Riparian zone on both sides of the Shima River, Peru
(Photo: Lindgren & Röttorp, 2007).

The riparian zone functions as a buffer zone which regulates the flow of many elements between surrounding land and the stream water. For example, trees and plants in the riparian zone can reduce the water velocity and increase the travel paths of the water. It can therefore result in deposits of sediment and attached nutrients. In addition, dissolved nutrients can be adsorbed by organic material and the mineral soil or be taken up by plants (Brady & Weil, 2002). Other elements, such as metals and contaminants can also be adsorbed or/and be taken up by plants in a similar way. Furthermore the vegetation zone helps to stabilize the stream banks by protecting the soil surface from impacts such as heavy rainfall and thereby decrease the risk of heavy erosion (Buffler, 2005) and partly by its soil holding capacity where the roots help to bind the soil (Brady & Weil, 2002; Buffler, 2005). The zone also provides habitat for stream biota, fish and terrestrial insects and shade of the water surface which reduces water temperatures and offers protection of aquatic water organisms by increasing the oxygen holding capacity of the water. Last, but not least, it provides organic material for stream biota (SVAP, 1998). The optimal design of a riparian zone is one that is densely vegetated and not overly trampled. That is how it should be built up to function at its best and be an effective buffer in order to decrease the amount of elements from reaching the stream water and thereby protect the stream health. Furthermore it should also have a width of six to sixty metres, although ten metres is usually sufficient to obtain most of the removing benefits (Brady et al., 1999). Many earlier studies have stated that the width is the most important variable in determining the effectiveness of the buffer to control the flow of contaminants into the streams (Buffler, 2005; Stream Visual Assessment Protocol, 1998). The land use adjacent to the riparian zone can easily affect the function of the zone and therefore it is important that the land use is carefully managed (Brady & Weil, 2002). Figure 3 shows an example of a riparian zone on both sides of a stream.

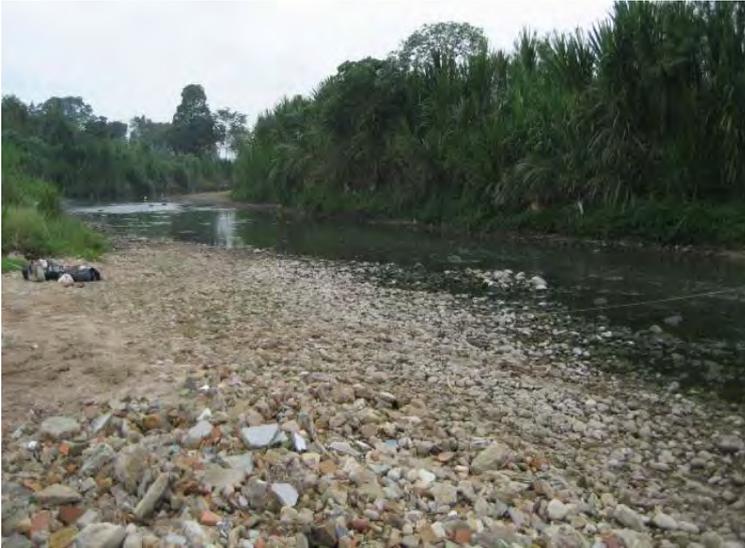
Figure 8 The site C1, looking downstream (Photo: Lindgren & Röttorp).

Site C1: Located downstream from Tarapoto and the airport. A lot of pollution is washed down into the river from the city. A road passes through the river. There is no or little forest and the vegetation on the banks is lower than at the other sites, consisting mainly of bushes and grass, see Figure 8. The water is used only for car washing. People collect sediment from the river bottom to add to concrete. Figure 8 shows a photo of site C1.

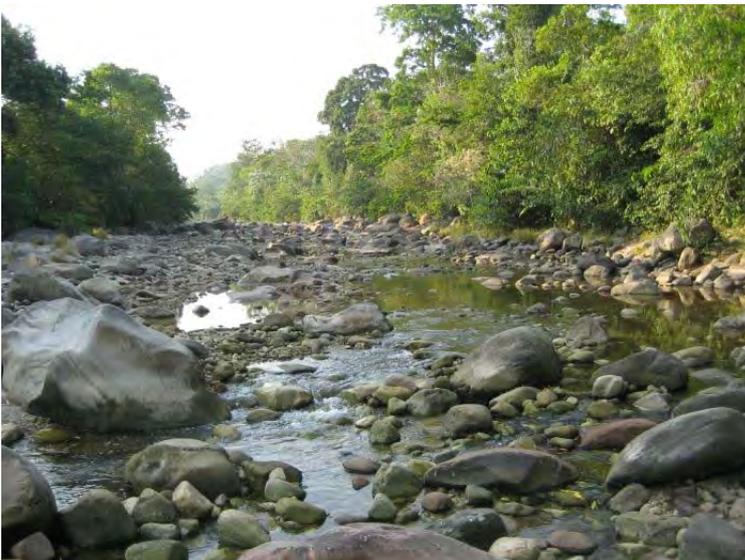
Figure 9 A short distance upstream site C2 (Photo: Lindgren & Röttorp).

Site C2: Buildings are located close to the river. There are farmlands, both large and small, close to the river. People pass here or in the close surroundings everyday and a road reaches all the way down to the stream. The water is used both for bathing and washing. Only secondary vegetation is found here and it is less dense than upstream, see Figure 9. Still the riparian zone is quite intact.

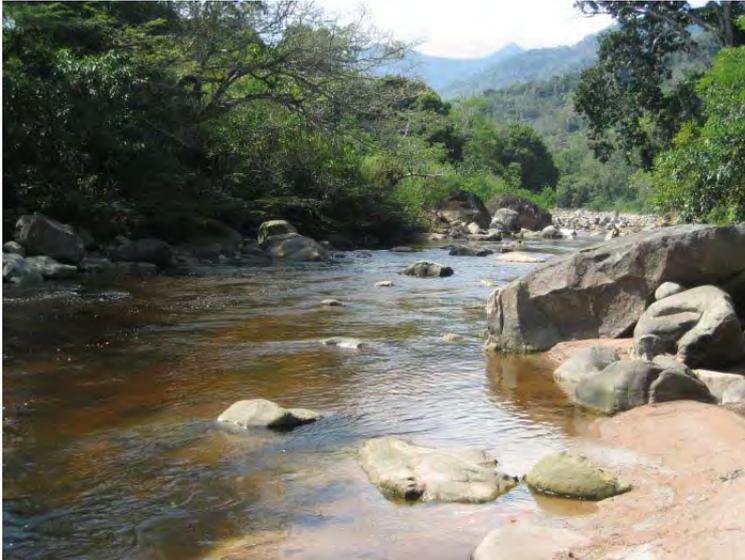
Figure 10 Site C3, looking upstream (Photo: Lindgren & Röttorp).

Site C3: This site is a popular recreation spot but the water is also used for washing and as drinking water. There are large farmlands in this area and the vegetation around the river is mostly secondary forest, see Figure 10. A big rice plantation receives water from the river upstream through a canal.

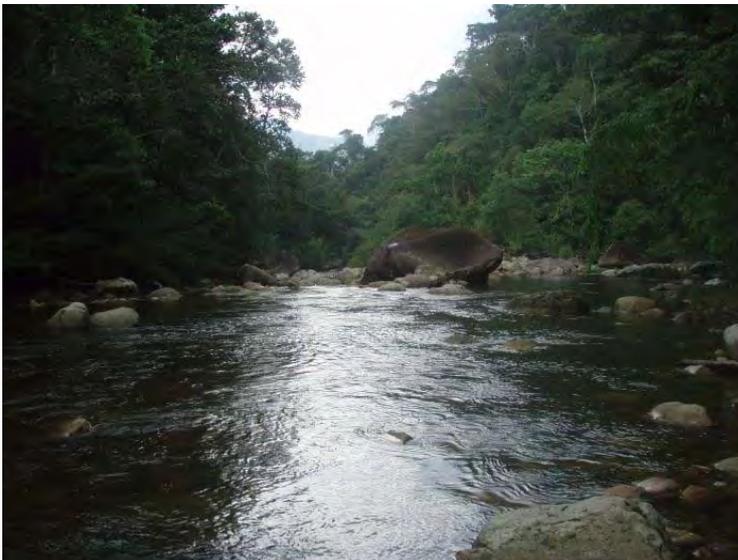
Figure 11 Site C4, looking downstream (Photo: Lindgren & Röttorp).

Site C4: This site is located in the hilly area, about one kilometre downstream from the village San Roque de Cumbaza in an area that is partly protected. The forest contains primary forest but also secondary - especially a bit upstream where some deforestation occurs. Tourists regularly visit this area but overall only a few find their way here. There are a few small cultivations close to this site but not adjacent to the riparian zone (Figure 11). The water is used mostly upstream from this site, closer to San Roque.

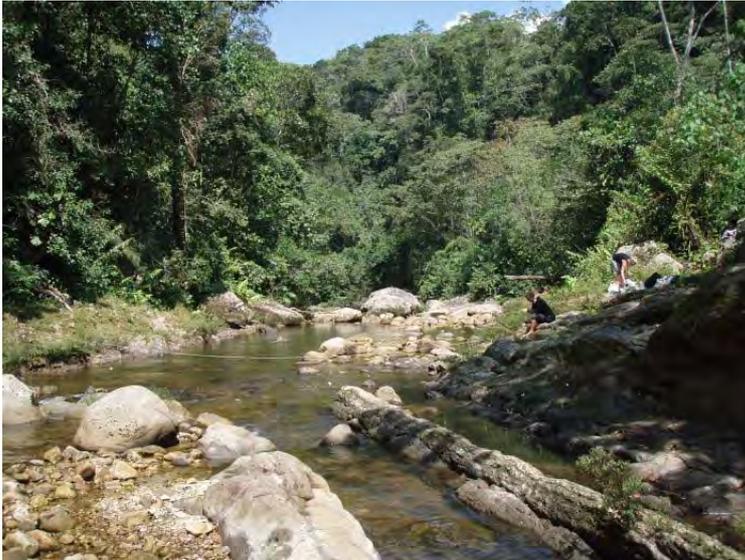
Figure 12 Site C5 (Photo: Vasques).

Site C5: This site is situated close to the village of Aviación with farmlands along one side, but not seen from the site (Figure 12). A path is also passing through the river why people and animals cross the river here several times a day. There is also a *tambo* (see footnote 24) close to the river where people rest and cook. The water from the stream at this location is used for water supply; washing etc. The stream is surrounded by mostly primary but also secondary forest.

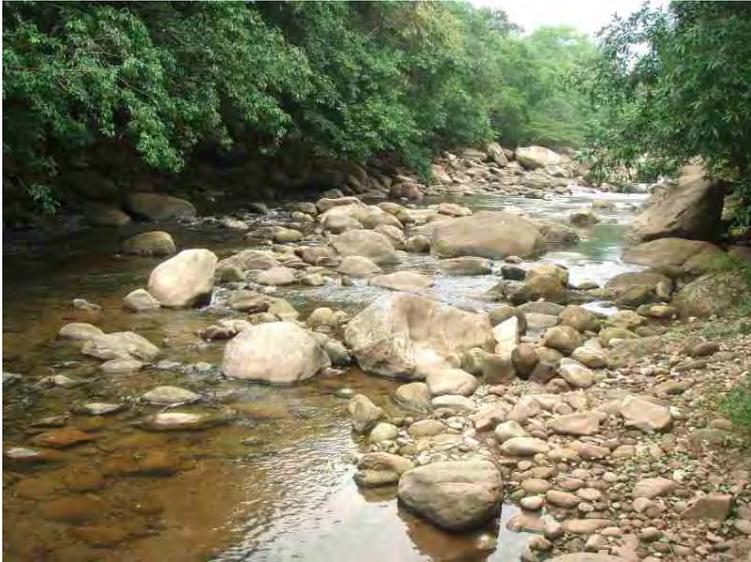
Figure 15 Site S1 (Photo: Lindgren & Röttorp, 2007).

Site S1: This site is situated close to a banana field and an enclosed pasture land. The character of the terrain in the surroundings along the stream bank at one side makes this site easily accessible for people but also for animals grazing on the pasture. Activities such as washing and bathing are very common. The vegetation is partly primary.

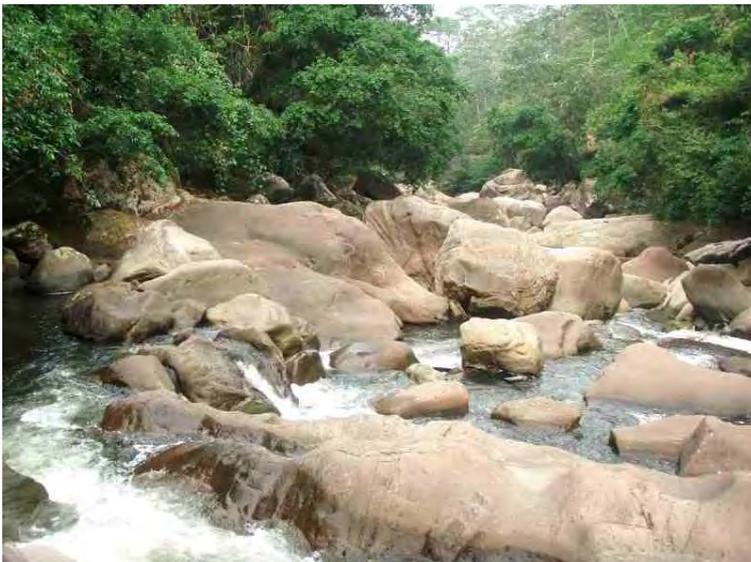
Figure 16 Site S2 (Photo: Lindgren & Röttorp, 2007).

Site S2: A water withdrawal is located 100 metres upstream from this site. Not many people are visiting this site, although the access is quite easy as a path reaches almost right down to it. It is not common for animals to use this path either, even though it cannot be excluded that they do. The vegetation is dense and partly primary.

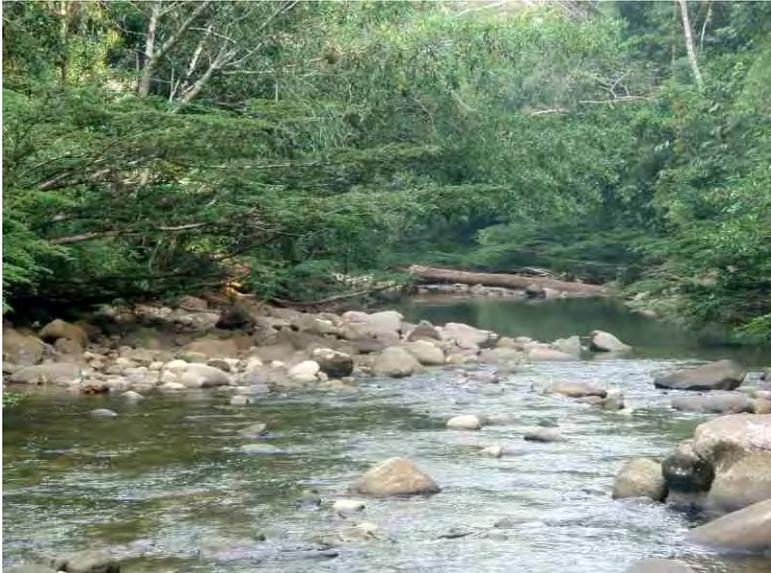
Figure 17 Site S3 (Photo: Lindgren & Röttorp, 2007).

Site S3: This site is situated close to large fields of rice, maize, cacao and bananas. No chemicals are used on these crops. People use the water here for laundry, washing and bathing. The vegetation is partly primary on both sides of the stream but is more fragmented on the left side (looking downstream).

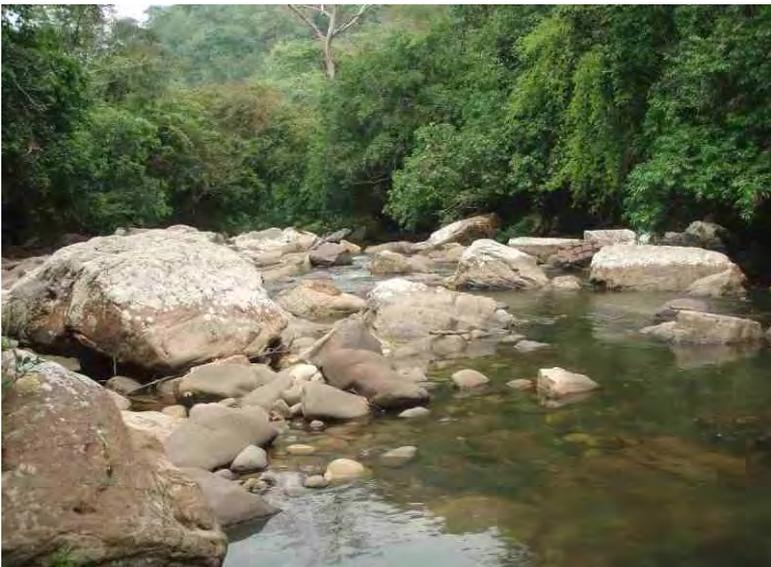
Figure 18 Site S4 (Photo: Lindgren & Röttorp, 2007).

Site S4: A field with rice and/or cacao is situated about 80-100 metres directly above this site. Animals such as horses and cows have access to the stream and people use the water for washing and bathing. The vegetation is mainly secondary.

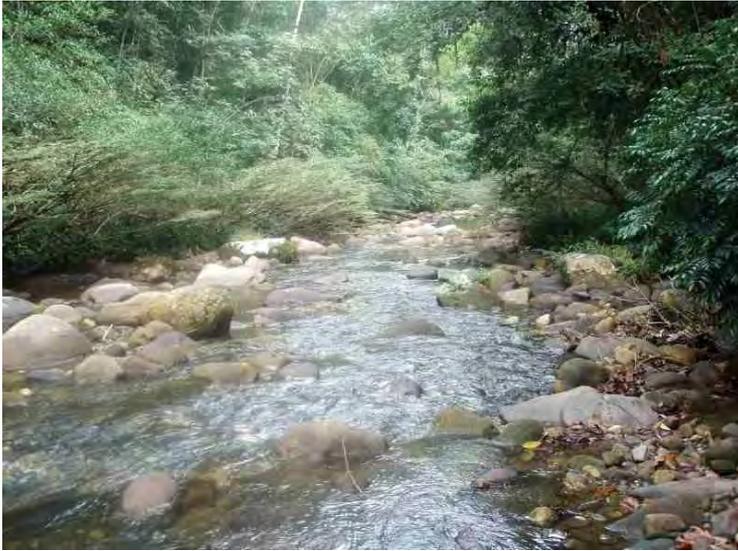
Figure 19 Site S5 (Photo: Lindgren & Röttorp, 2007).

Site S5: A larger cropping field is located about 20 metres just above the riparian zone directly above the site. Very few people visit this site but among those few that do visit bathing can occur. There is no evidence of animals even though it is probable that horses and/or donkeys walk along the path stretching along the field. The vegetation is dense at this site and mostly secondary.

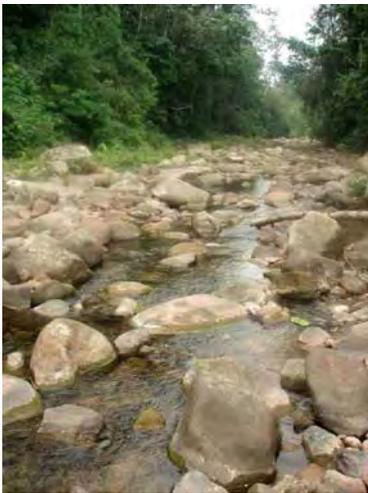
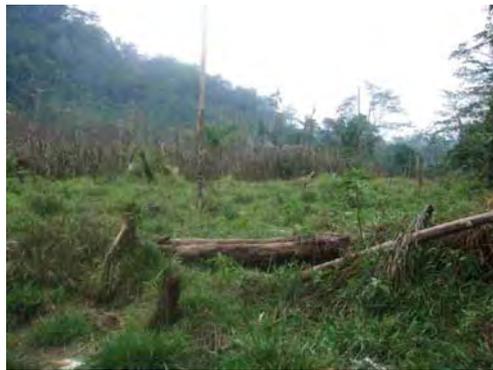
Figure 20 Site S6. The stream (left) and adjacent slash and burn field (right). (Photo: Lindgren & Röttorp, 2007).

Site S6: A slash and burn farming site is situated at a distance of 4-5 metres from the stream. People living nearby use the water for washing (approx. 5 people). A smaller village is located about 100 metres upstream and people there also use the water for washing and bathing. There is evidence of some manure just close to the riverbank which proves that animals may have access to the stream. The vegetation is partly primary.

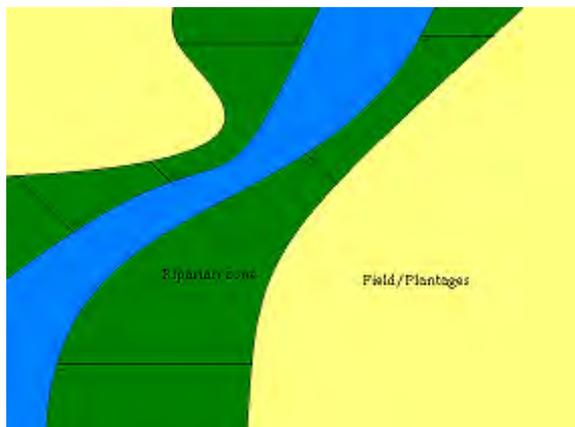
Figure 25 Three perpendicular transects on each side of the stream.

This parameter was graded by measuring the width of the riparian zone on three chosen transects on each side of the river. All transects were chosen so that they together, as good as possible, represented the complete riparian zone (Figure 25). Where the riparian zone was composed of rugged terrain the distance was measured with a GPS, otherwise simply by a tape measure. A mean value was calculated for each side and this value represented a certain score according to the SVAP scoring sheet. The value that corresponded to the lowest SVAP-score was entered into the protocol.

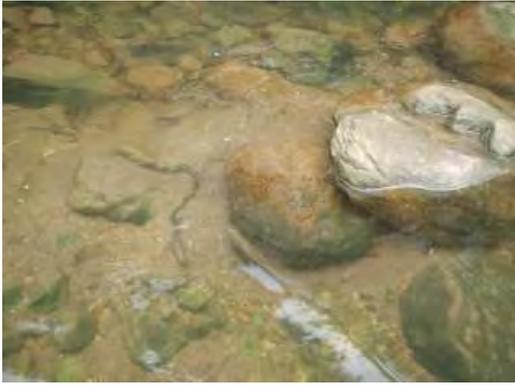
Figure 26 Stones partly embedded in bottom sediment (Photo: Lindgren & Röttorp, 2007).

Riffles are areas where the water is breaking over rocks or other debris. The degree to which gravel and cobble substrate are surrounded by fine sediment relates directly to the suitability of the stream as a habitat for fish spawning. Figure 26 shows an example where stones are partly embedded in sediment in the Shima River. We graded this parameter through estimation of the percentage of the gravel and cobbles covered with sediment. A percentage distribution was used to assist the estimation (Appendix 3).

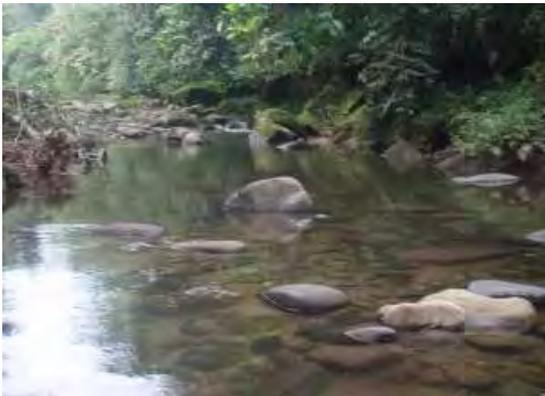
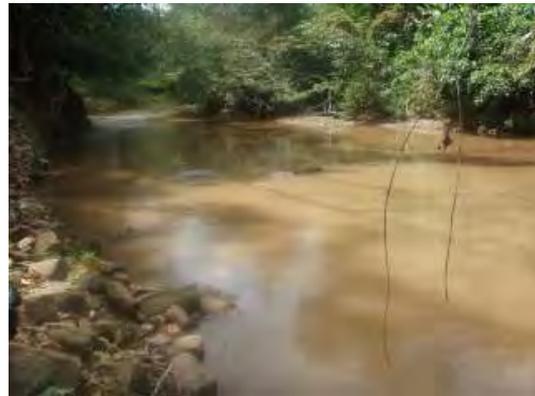
Figure 27 Water with a clear appearance (left) and water with a great amount of suspended material (right) (Photo: Lindgren & Röttorp, 2007).

This parameter is all about the amount of suspended material in the water. Suspended material in the water causes turbidity which is an indicator of water clarity or the ability of dissolved material to spread and absorb light. Turbulent water allows smaller amount of light to penetrate into the water. This can reduce the photosynthesis among photosynthetic organisms in the water and in turn reduce the amount of oxygen produced by these aquatic organisms. The result could be a lack of oxygen in the water. This parameter was graded visually by investigating how clear the water appeared to be. Pictures from a reference site were used as a comparison. Figure 27 shows examples of waters (from the Shima River) with different appearance.

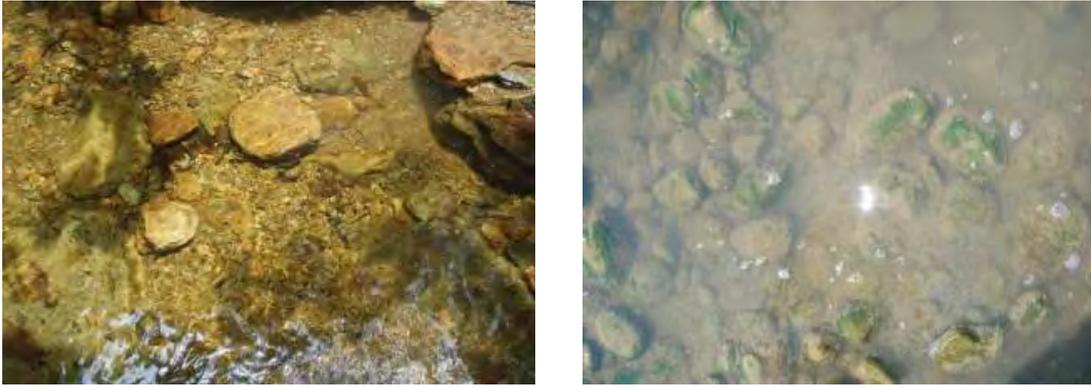
Figure 28 Stones with a lack of algal growth (left) and stones with a great amount of algal growth (right) (Photo: Lindgren & Röttorp, 2007).

The amount and type of aquatic vegetation in the stream can work as an indicator of the amount of oxygen in the water. Decomposition of aquatic vegetation results in an increased consumption of oxygen among decomposers. This results in a decreased amount of oxygen in the water which creates stress among the organisms living in it. Agricultural activities can result in increased amounts of organic material in the streams and thereby have an enrichment effect. This parameter was graded by visually estimating the colour of the water and the amount of algae on stones and other material covered by the water. Pictures from all of the sites along one river were compared to give a relative score. The left picture in Figure 28 is from the site most upstream, C6, in Cumbaza and shows stones that lack algal growth whereas the right picture is from the site downstream Tarapoto, C1, in Cumbaza and shows massive algal growth.
