Temporal water quality study of the heavily human-impacted Likangala River, Zomba, Malawi

Minor Field Study 193
ISSN 1653-5634

Februari 2015 Uppsala

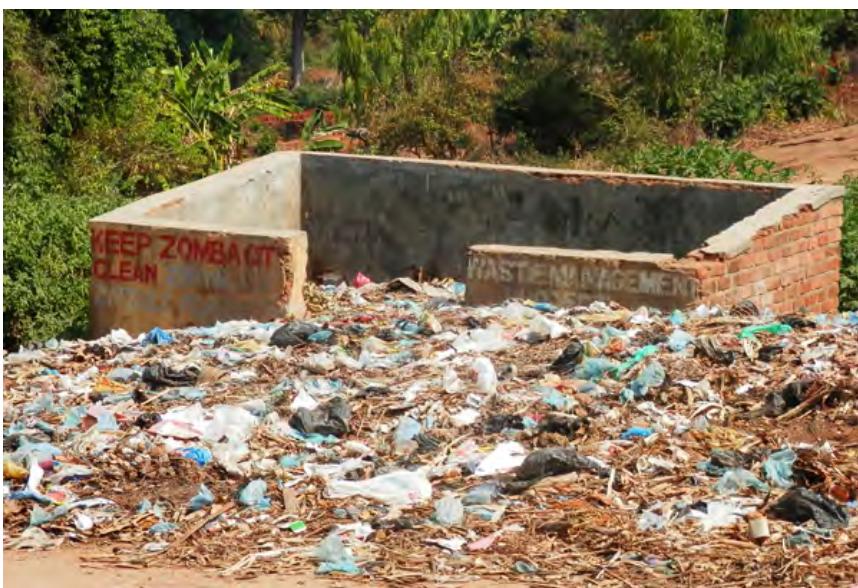
Figure 3. Example of unsatisfactory waste management, where indiscriminate waste is accumulated along roadsides.

The management of sanitation and removal of waste in the city is poor according to UN Habitat (2011), especially outside the high-income areas. The residents of the informal settlements do not have access to waste collection at regular intervals, and the bulk of the waste ends up in rubbish pits, in and around the rivers, in traditional pit latrines and along the roadsides (Figure 3). Buildings for public institutions such as hospitals, Zomba Central Prison and the university, along with a fraction of the residential houses are connected to a gravity-fed sewer system, transporting wastewater through the local wastewater treatment plant (WWTP) to the Likangala River (UN Habitat, 2011). This wastewater treatment plant however, has shown poor performance in treating the water, as proved by previous studies (Chidya *et al.* 2011; Lundgren, 2013).

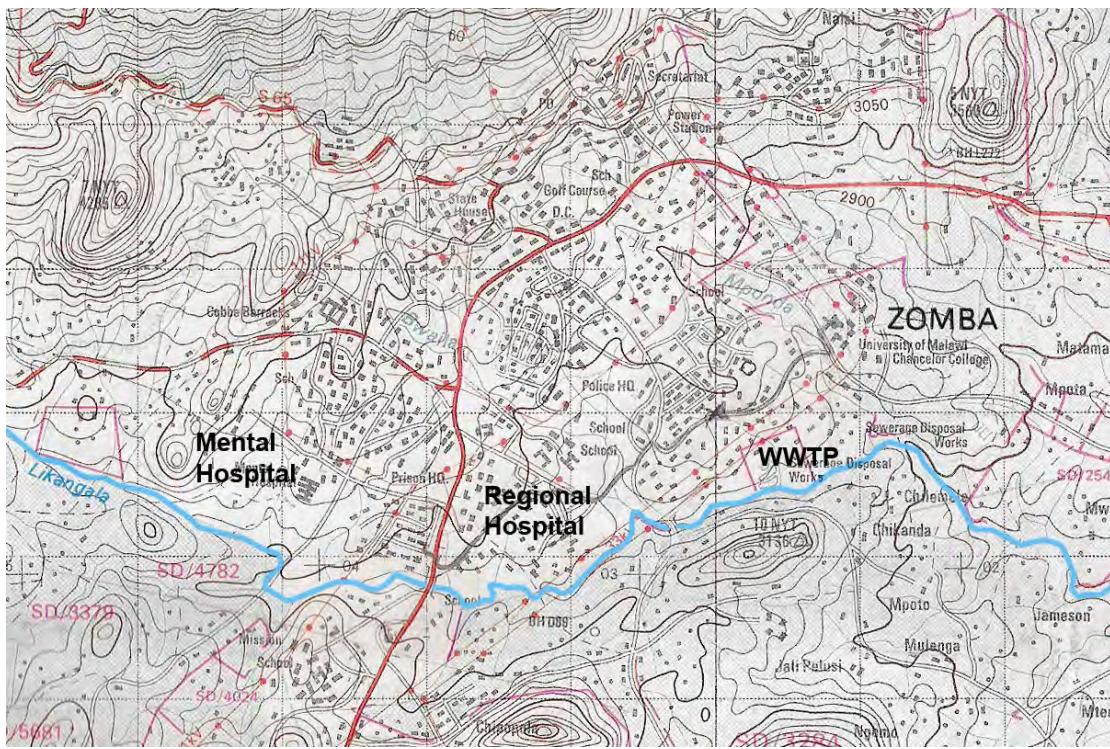
Figure 4. Topographic map of Zomba city, showing the flow of Likangala River (Department of Surveys, 1980).

Likangala River flows from west to east, through the southern parts of Zomba city (Figure 4) towards Lake Chilwa. In this project, the middle section of the river is studied, where it passes the city. The studied stretch measures just under 6 km, passing near a mental hospital, the central hospital, commercial and residential areas and the wastewater treatment plant, from which effluents are expelled. The river is perennial, with a large difference in water discharge over the year, with a peak in wet season, which normally occurs around November until April. The field data and water samples are collected during October, which is in the dry hot season.

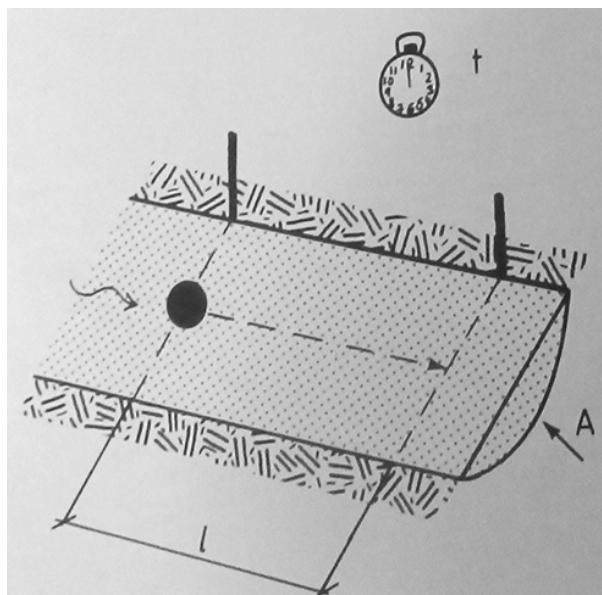
Figure 5. Measurements of water discharge with float method (SMHI / SNV, 1979)

By observing the time (t) it takes for a floating object to travel with the water flow down a segment of known length (l) and cross sectional area (A), the water discharge (Q) of a stream or river can be estimated (Figure 5). The method only gives a rough estimate of the water discharge (error between 30 and 70%), but it is a simple and affordable procedure that needs very little equipment and can be conducted by one or two people. An adjusted value of the maximum surface velocity (v_{max}) gets to represent the average velocity of the whole section.

The constant k in (1) is a value usually between 0.5 and 0.9, where a low number represents a section with high bottom roughness and a high number a section with low bottom roughness (SMHI/SNV, 1979).

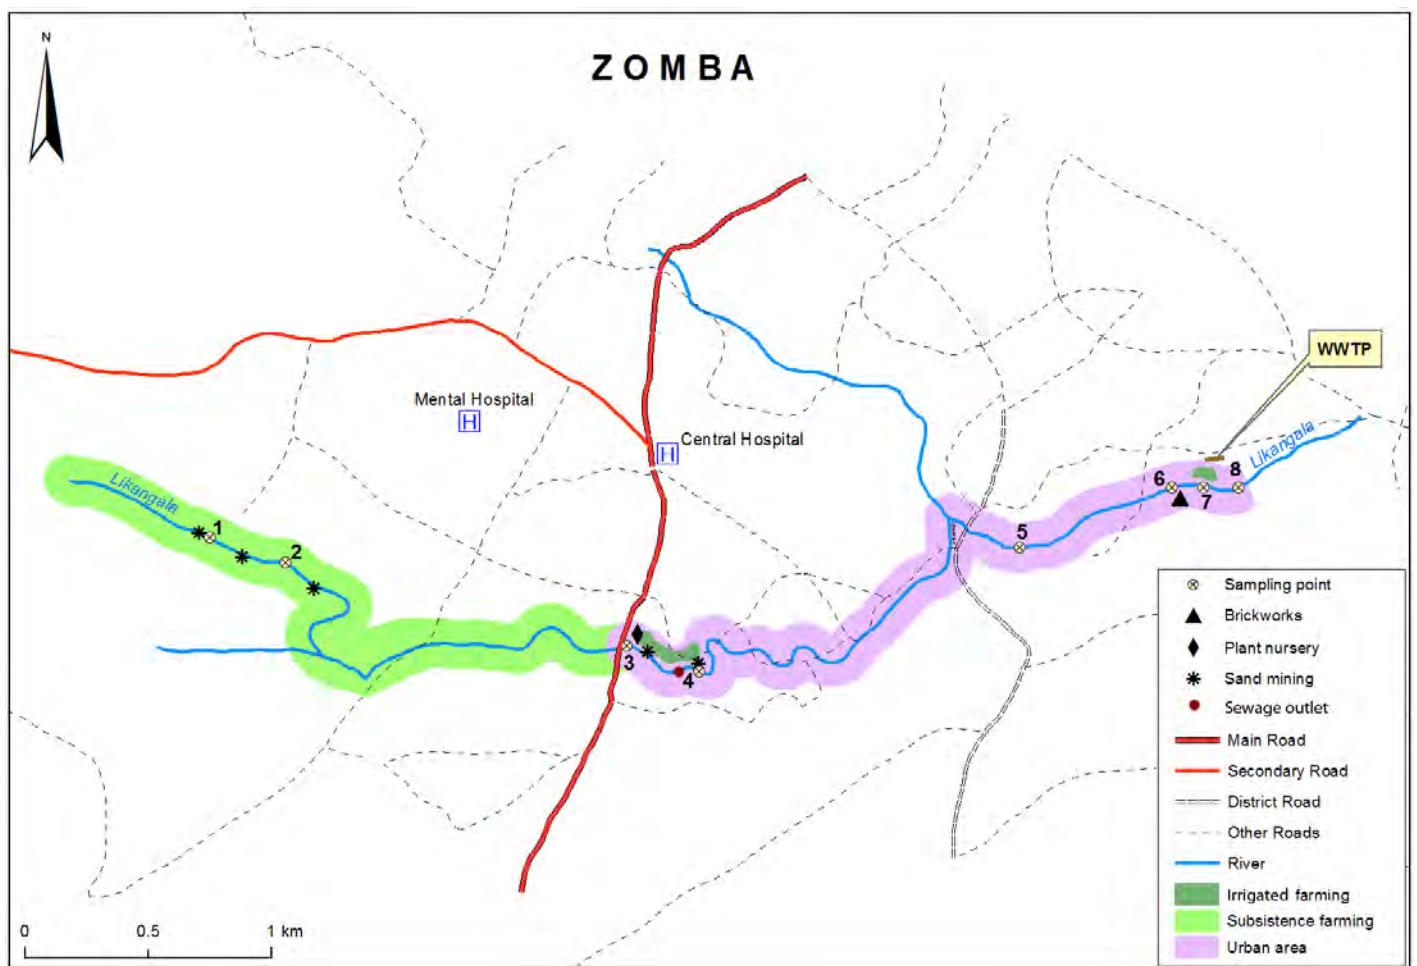
Figure 6. Map of land use and activities. Sampling points for water quality parameters are numbered from 1 to 8.

The study area can be divided into two main sections. The upper part of the study area, upstream of the main road is predominantly rural (Figure 6), characterised by subsistence farming and settlements scattered over the landscapes. The area downstream of the main road is predominately urban, with houses close to the river, especially on the northern side of the river.

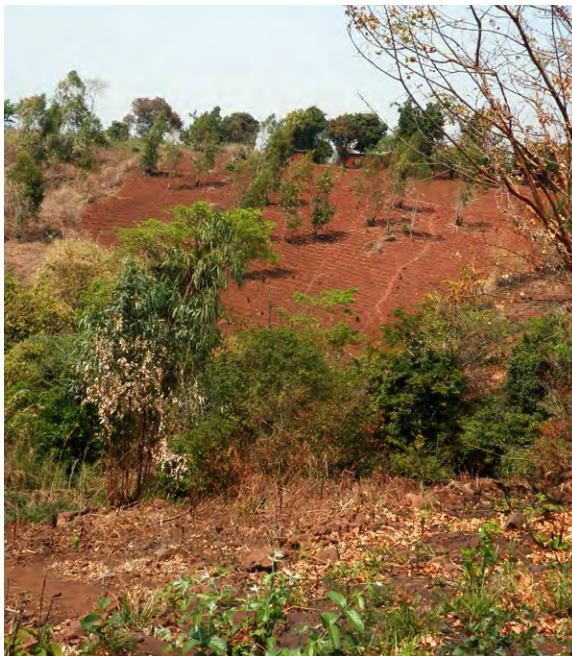
Figure 7. The slopes of the Likangala River, characterised by bare soil. The river flows in the middle of the picture, where it is lined with trees.

The upper part of the river flows along a v-shaped valley, with the gentle slope on both sides being utilized for growing crops, such as maize and beans, along with scattered fruit trees. The bulk of the active farming happens during the wet season, so during the time of this study most soil was bare (Figure 7), ordered into neat rows. The farmed soil reached all the way down to the river in some places, but mostly the river was lined with trees and bushes.

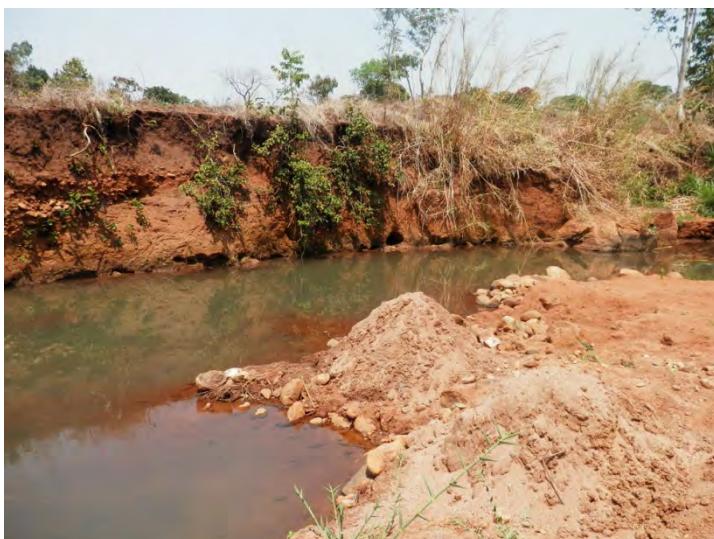
Figure 8. Sand mining location. Also visible is the eroding riverbank on the far side.

Spots of sand mining were observed along the entire studied stretch of the river, characterised by piles, or small fields of sand next to the water (Figure 8). A few of the notable locations are shown in Figure 6. In the urban area, people temporarily damming the water flow as a means to facilitate sand mining was observed.

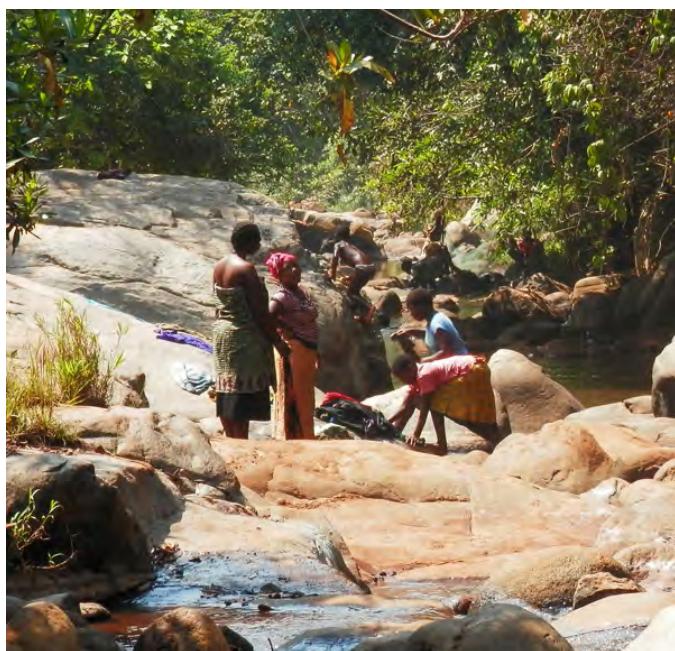
Figure 9. Washing and bathing in the river.

Both upstream and downstream of the main road, laundry activity was observed, with fabrics being washed manually with detergent and then rinsed (Figure 9). Also people and children bathing and washing were observed.

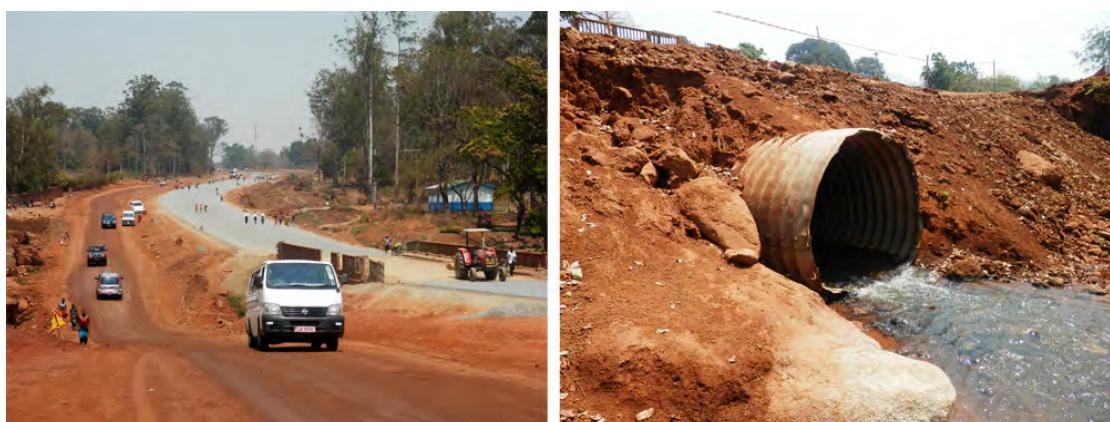
Figure 10.Road construction, temporary bridge with culvert to the left.

The main road crosses the river in the middle of the studied area. Currently, there is major road construction taking place, upgrading and paving the road leading to Blantyre (Figure 10). Due to this, a temporary bridge is established next to the old one, with all river water being diverted through a circular culvert. The sand, gravel and dust moved around by large machinery are likely to affect the load of suspended solids in the river downstream.

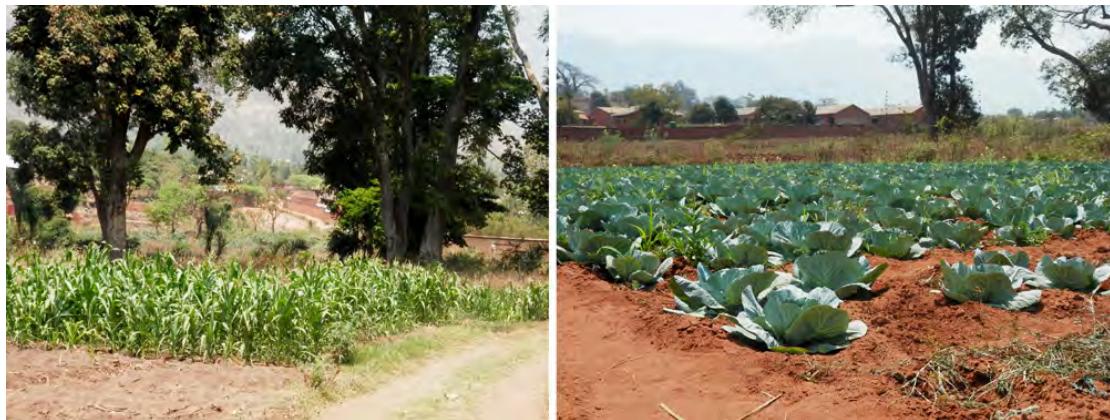
Figure 11. Irrigated farming of maize (left) and cabbage (right).

Immediately downstream of the bridge is a plant nursery. Irrigated farming of maize, potatoes, cabbage, tomatoes among other things (Figure 11), occurs on the north side of the river. The irrigation water is taken from the river.

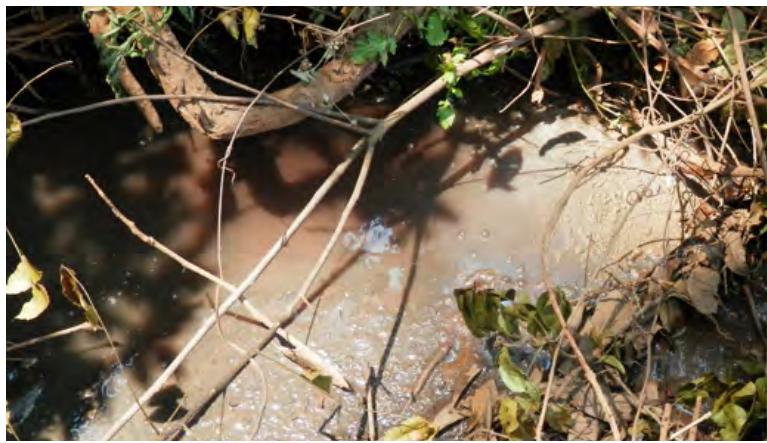
Figure 12. Stream joining the Likangala, with appearance and odour of untreated sewage.

At this site, a small tributary to the river from the north side was observed. The water joining the Likangala here was brown and murky, and carried the distinct odour of sewage, very possible effluents from some sort of toilet facility (Figure 12).

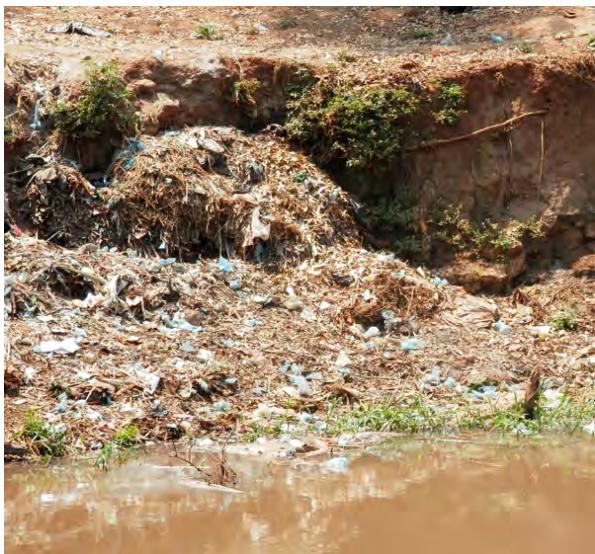
Figure 13. Indiscriminate mix of household waste along the river.

The next segment of the river flows through a very urban area, in the southernmost part of Zomba. The houses here are small and with little space in between. Along with laundry and bathing, the most striking feature was the indiscriminate mix of household waste scattered along the riverbank (Figure 13).

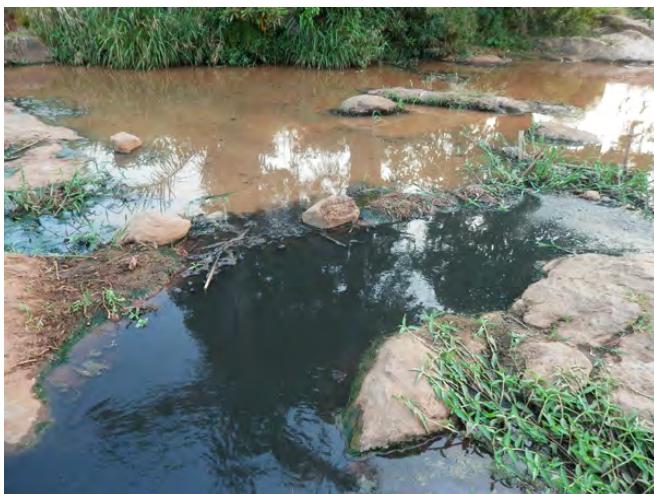
Figure 14. Dark wastewater treatment plant effluents joining the clearer water of the river.

The study area ends just downstream of Zomba Sewage Works, where the wastewater from the hospital, and the settlements gets treated biologically in a succession of ponds. Some of the wastewater was used to directly irrigate maize on the site. The water in the outlet from the wastewater treatment plant into the river had a dark, blackish colour and a distinct smell of sewage (Figure 14). Downstream of the outlet substantial algae growth was observed, due to the nutrient load from the wastewater effluents (Figure 15).

Sample point seven, corresponding to the outlet stream from Zomba WWTP, shows more extreme values for all parameters, except turbidity. This indicates that the treatment process is insufficient, which is also confirmed by the dark, blackish color and the foul odour of this stream. From sample point six to eight, i.e. immediately before and immediately after (100 m in each direction) the outlet, a significant rise in nitrate, sulphate and phosphate can be noted, and that cannot be explained by something other than impact of the wastewater joining the river. Given that the total discharge of the river was estimated to only 61 l/s a short distance upstream, and by visual approximation was similar (same order of magnitude) at end of studied area during the dry season, the flow from the WWTP will have a huge effect. Algae

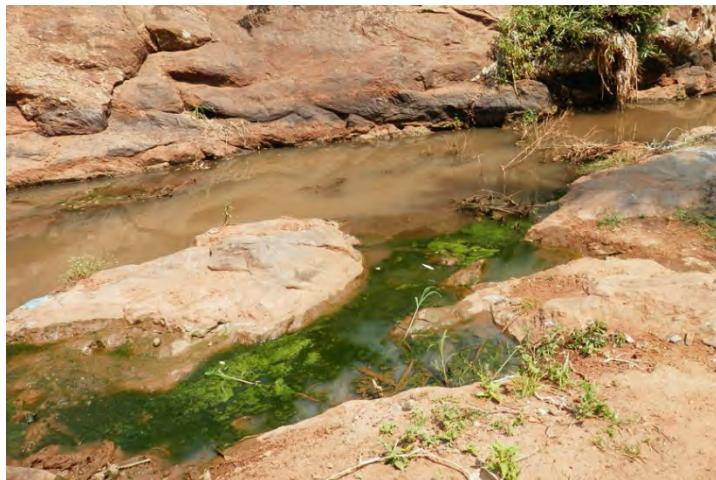
Figure 15. Algae growth downstream of the wastewater treatment plant outlet.

growth was observed just downstream of the outlet, but nowhere else along the studied area, suggesting a strong effect of the expelled nutrients.

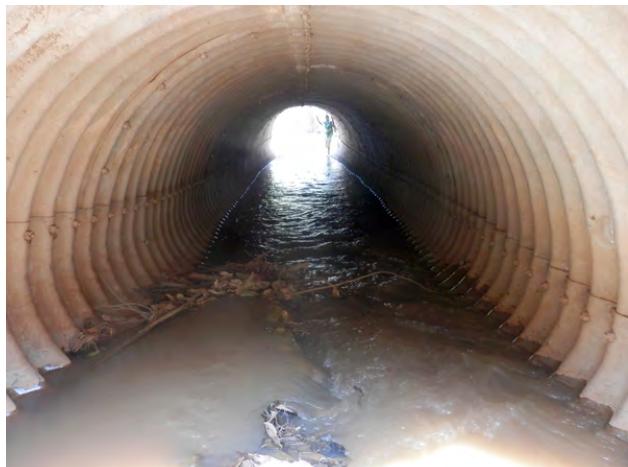
Figure 16. The culvert at the road construction site, used for approximating water discharge in Likangala River.

The shape of the corrugated culvert was round, slightly oval, with a flatter section in the bottom (Figure 16), probably due to the pressure from above. Hence the cross sectional area of the water was approximated with the shape in Figure 17, and not with a segment of a circle. This gives a total area of 0.16 m^2 . The length of the culvert was 15 m.

The floating device used was a piece of a stick found at the site, and the experiment was repeated five times, of which the average was 19.3 s and the standard deviation 1.7 s. The value of k was chosen to 0.5, due to the corrugated surface of the culvert, and hence a substantial amount of turbulence. With this data, the v_{max} was estimated to 0.78 m/s, and the water discharge to 61 l/s, using formula (1).

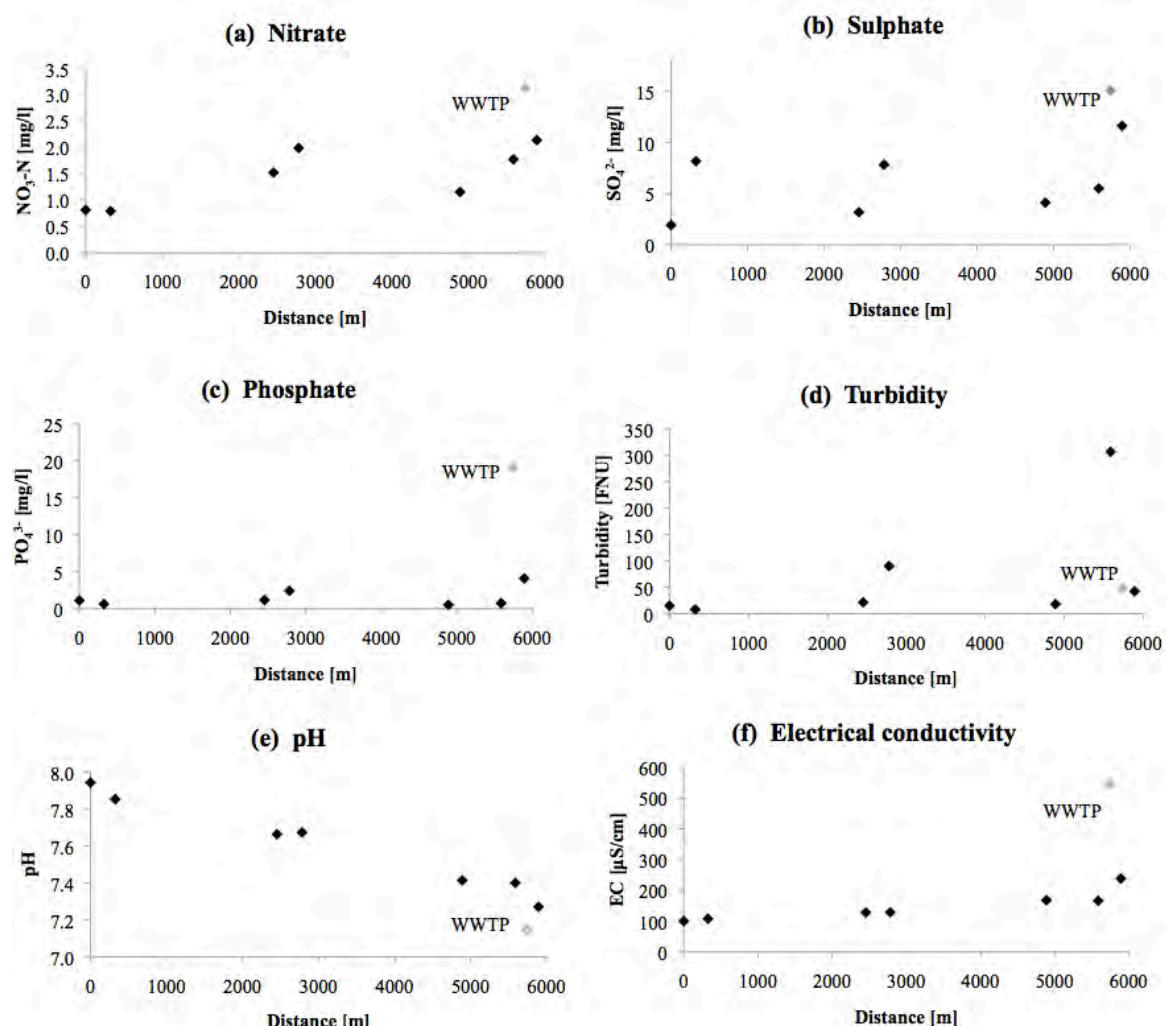
Figure 18. Spatial variations (a-f) of nitrate, sulphate, phosphate, turbidity pH and EC for the eight different sampling points. Results from WWTP effluents marked grey.

The turbidity varies a great deal, and does not show a trend, either positive or negative. Although the highest value was measured towards the end of the studied area, where the water was particularly brown and murky from suspended particles. Turbidity is likely affected by the flow regime, where local eddies and rapids stir up sediments, the presence of road works, people walking on the riverbed stirring up particles and sandmining in action.

The pH value varies with almost a full unit along a clear negative trend, indicating a continuous addition of acidic substances, or acidification processes happening instream, possibly connected with poor buffer capacity of the water. Alkalinity, along with a detailed description of possible buffering rock types in the area would be interesting to look into in another study.

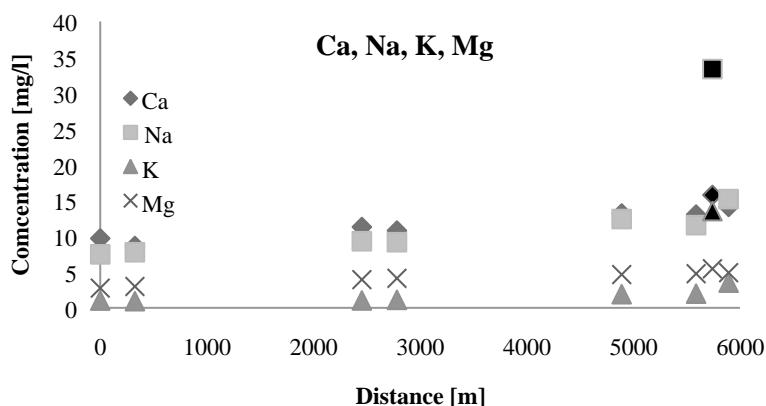
Figure 19. Spatial variations of calcium, sodium, potassium and magnesium for the eight different sampling points. Results from WWTP effluents marked black.

Calcium, sodium potassium and magnesium (Figure 19) all show a clear positive trend with distance, again with higher concentrations in the WWTP effluents, again showing an increase from sample point six to eight, however not as drastic as for the anions. Sodium stands out, which is reasonable, given that the salt concentration in domestic wastewater often is high. Sample point four does not stand out for these parameters, but actually decreases slightly. An possible explanation to the increase of these cations, and at the same time a clear positive trend of electrical conductivity could be enrichment due to evaporation of river water, which is significant in tropical climates like Malawi (river water temperature around 29° C).

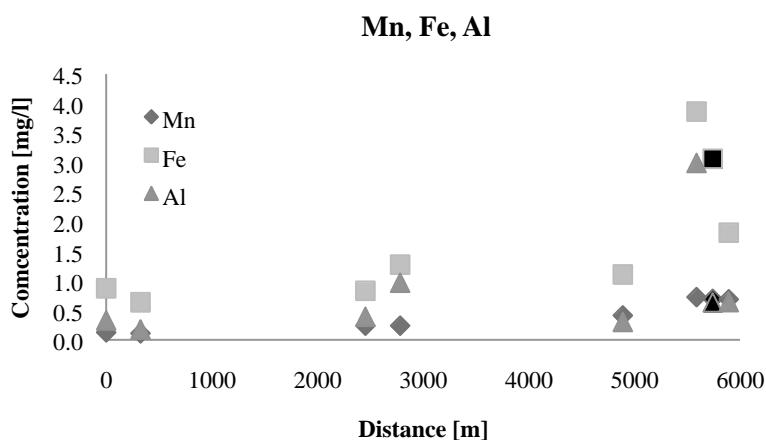
Figure 20. Spatial variations of manganese, iron and aluminium for the eight different sampling points. Results from WWTP effluents marked black.

Of manganese, iron and aluminium, only manganese shows a significant trend with distance, whereas iron and aluminium have a maximum just before the WWTP effluents join in. This cannot be explained by the results in this study, but can possibly come from a point source of pollution.

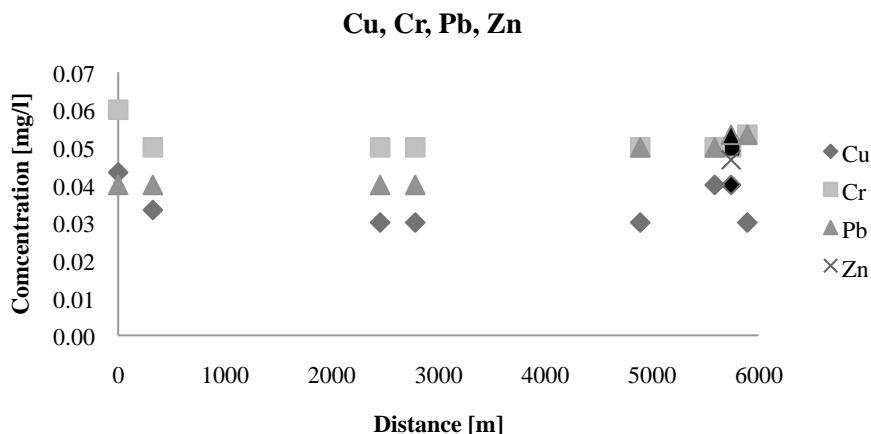
Figure 21. Spatial variations of copper, chromium, lead and zinc for the eight different sampling points. Results from WWTP effluents marked black.

Copper, chromium, lead and zinc remain quite constant on small concentrations with no clear trend, although lead seems to increase, however slightly (Figure 21). It is very likely that there are errors with the measurements of these elements, related to detection levels and use of an unsuitable range of calibration values.
