Environmental impacts of the Rio Esti Hydroelectric Project, Panama

Erik Wall

This paper has been done as a project course of 15 ECTS points in Aquatic- and Environmental Engineering at Uppsala University, Sweden.

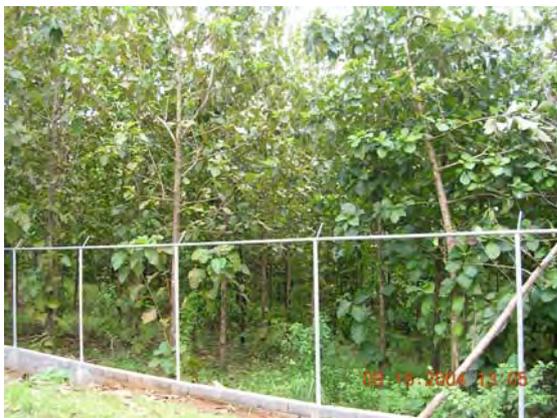
AES has been planting trees at some 400 ha in the project area, mainly as an erosion protection measure (Fig 6.1). A forest works to avoid erosion in mainly four ways. First, vegetation decreases the amount of water to reach the ground during precipitation, since a number of raindrops are caught in the canopy and evaporates from the leaves, without ever reaching the ground. Secondly, water drops that don't evaporate from the canopy have a lower impact speed when reaching the ground, since a number of the falling drops are slowed down, or split into smaller drops, by leafs (The kinetic energy of the precipitation is generally considered to be the main factor causing erosion.³¹). Thirdly, the roots of trees reinforce the soil which will therefore not be eroded as easily even if run off occurs. Fourthly, trees act as windbreakers decreasing wind velocity at the ground and hence lessening wind erosion.

Fig 6.1 A 4-5 year old teak plantation closely east of the Canjilones powerhouse.

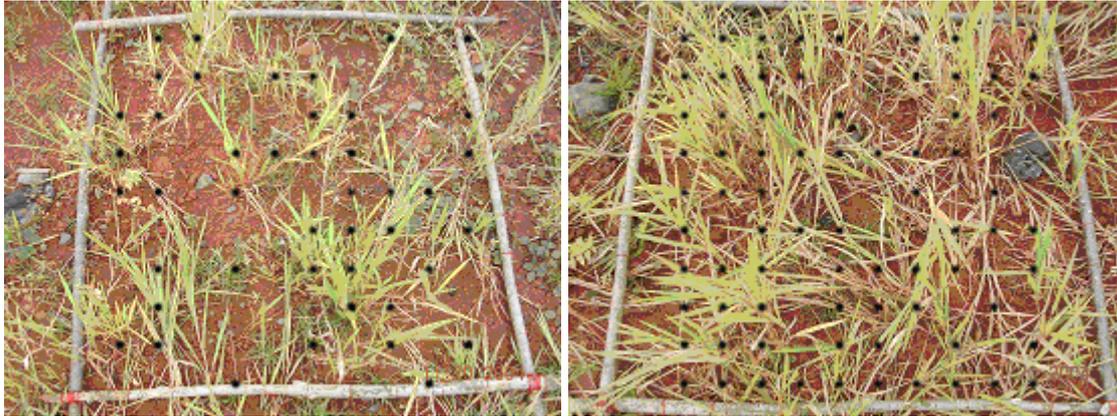
Fig 6.2 To the left, a 1 m² with a 44% vegetative cover. To the right, a 1 m² with 74% vegetative cover. Black dots show where grid intersections were located over vegetation. The grid used is not shown in the photos.

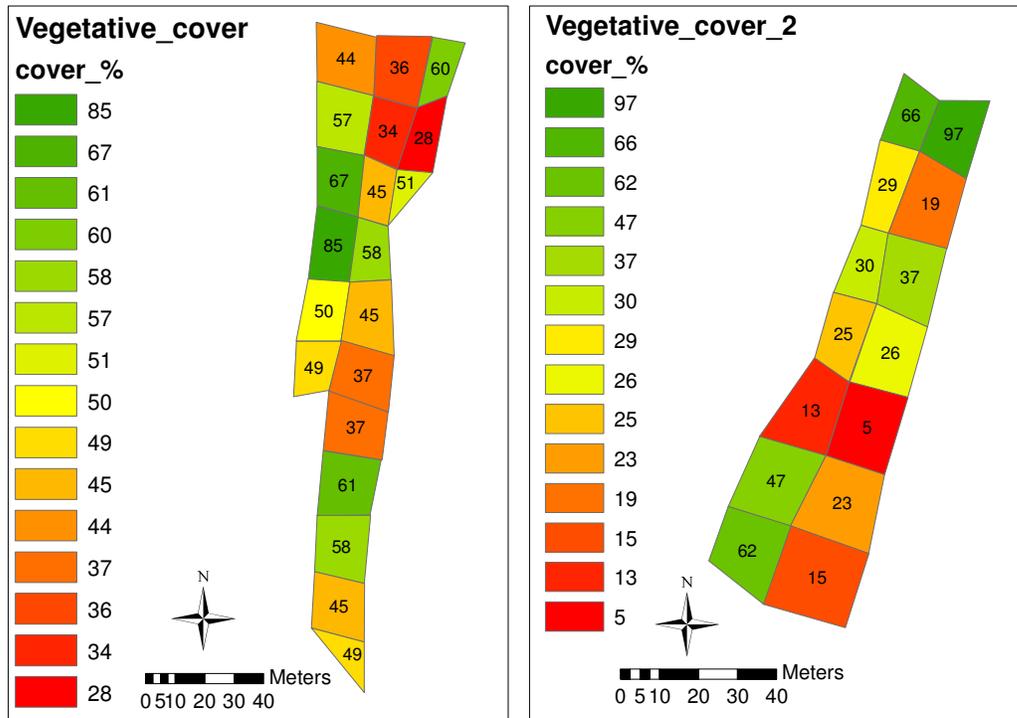
Where topsoil have been added and grass planted the vegetative cover is higher than at similar nearby areas left to natural re-colonization (Fig 6.6). The cover is however uneven also at actively re-vegetated sites. As a result, the added topsoil is eroding to some extent (Fig 6.5). The problems with erosion seems, maybe a bit contradictory, to be bigger at areas where topsoil has been added and active re-plantation performed than at areas left to natural re-vegetation. The ground at abandoned sites with no added topsoil is often very compact and consists mainly of gravel or stones, material resistant to erosion because of their size and weight. Erosion that is observed at these sites is almost solely occurring as gullies forming in slopes. (Fig 6.5)

Fig. 6.6 To the left the vegetative cover in percent for an area with top-soil added and grass planted (southern point at z17 E-357197 N-944787). To the right, the vegetative cover for a nearby area that has been left to natural re-colonization (southern point at z17 E-357292 N-945397).

Areas left to natural re-colonization show a very wide range in how far plant re-colonization has reached at this stage, even though they have been left abandoned for approximately the same amount of time. The reason for this could be differences in the ground materials, or differences in how compacted different areas have been. The more compact the ground is, the harder it is for plants to colonize.

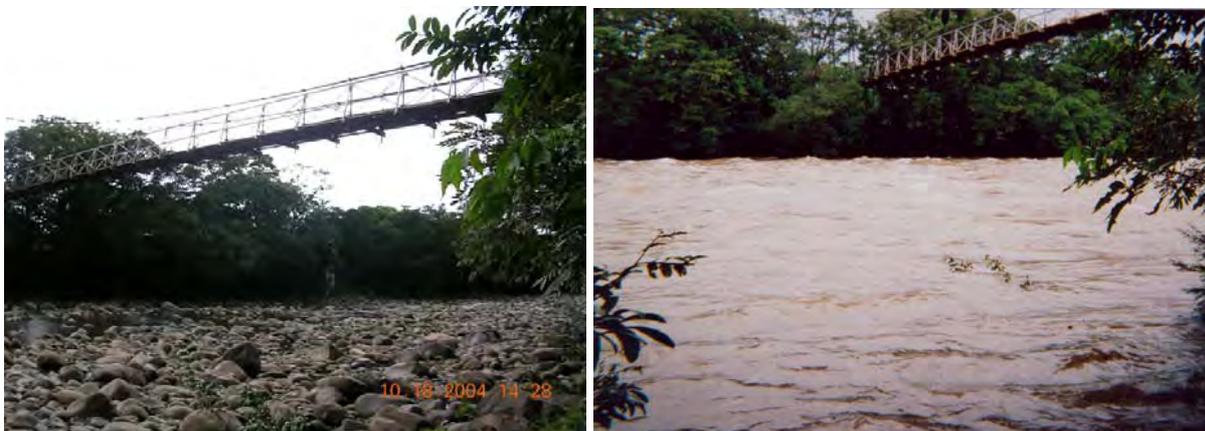
Hence, the average flow of the river has decreased significantly. However, occasionally due to intense rains, excess water is released from the Chiriqui Reservoir through overflow weirs. This causes a very rapid increase in the river level of up to three meters within minutes. This is observed by the people in the area and corroborated by water level graphs. During the months of October and November 2004, such an increase occurred 30 times.

Fig 7.1 The Chiriqui River under the bridge between La Esperanza and El Carrillo. The left picture shows a low flow situation and the right a high flow situation. Both pictures are taken during October 2004, (right picture taken by a villager in La Esperanza) (z17 E-353159 N-950229).

The Chiriqui River has been a regulated river since the construction of the Fortuna hydroelectric plant in 1984 and heavy rains are normal in the mountainous part of the catchment area. Rapid increases of the water level have therefore occurred earlier, but these water level changes are since the construction of the Rio Esti project both more frequent and more rapid than earlier. They are also more unpredictable than before the project according to some of the people living close to the river. No warning system, similar to the one constructed on the Esti River downstream from the powerhouse, exists to alert people prior to dam releases.
